IBI Group
30 International Boulevard
Toronto ON M9W 5P3 Canada
tel 416 679 1930
fax 416 675 4620

September 10, 2012

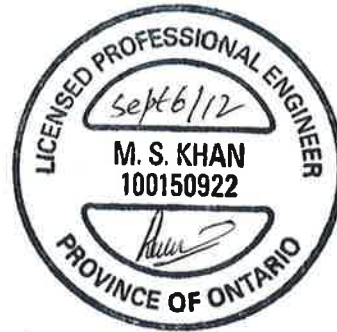
Sarfraz Khan, M.Eng., P.Eng.
Field Operations Supervisor

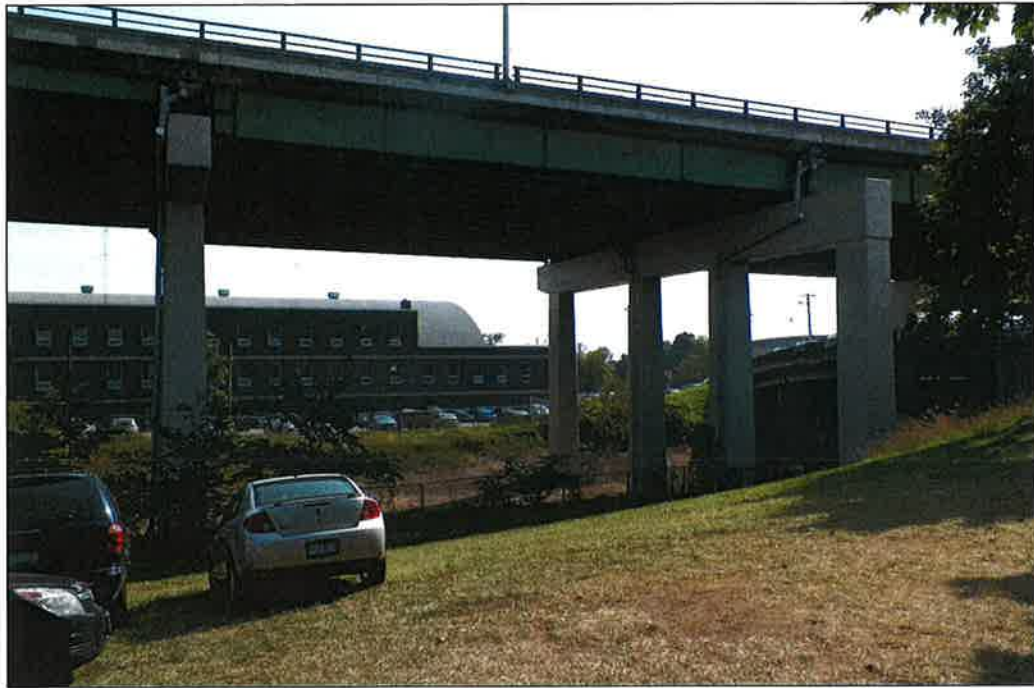
Photo P1 – Elevation (Bent 53-55) (fair condition – stained and unstained cracking, delaminations, isolated spalls, patches, wet areas and light scaling)

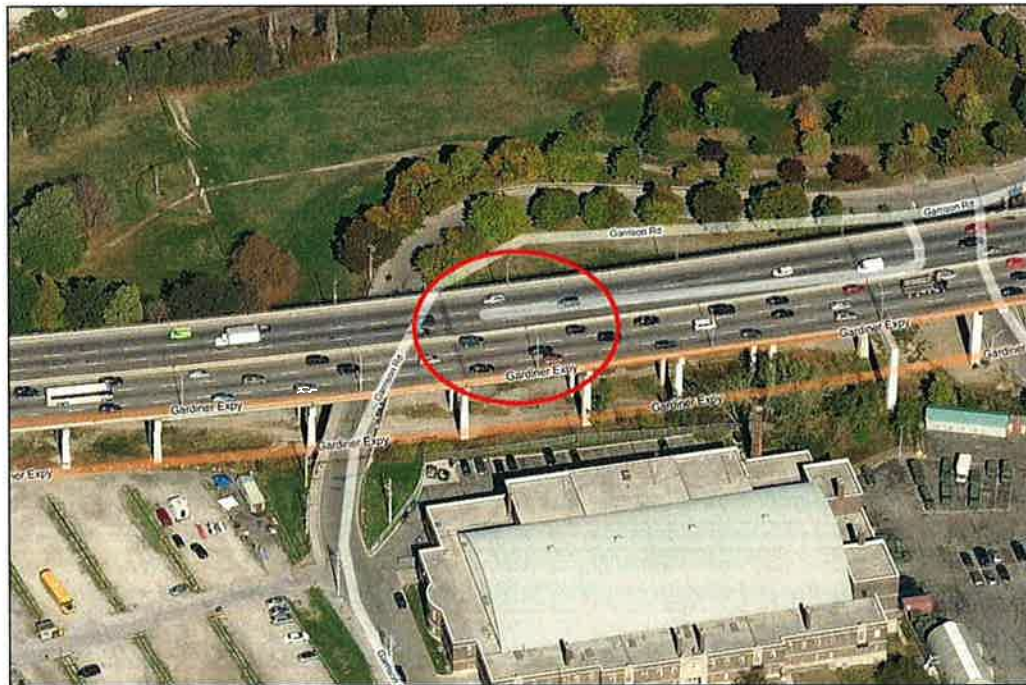
Photo P2 – Aerial Overview of Structure (Bent 53-55) (fair condition – stained and unstained cracking, delaminations, isolated spalls, patches, wet areas and light scaling)

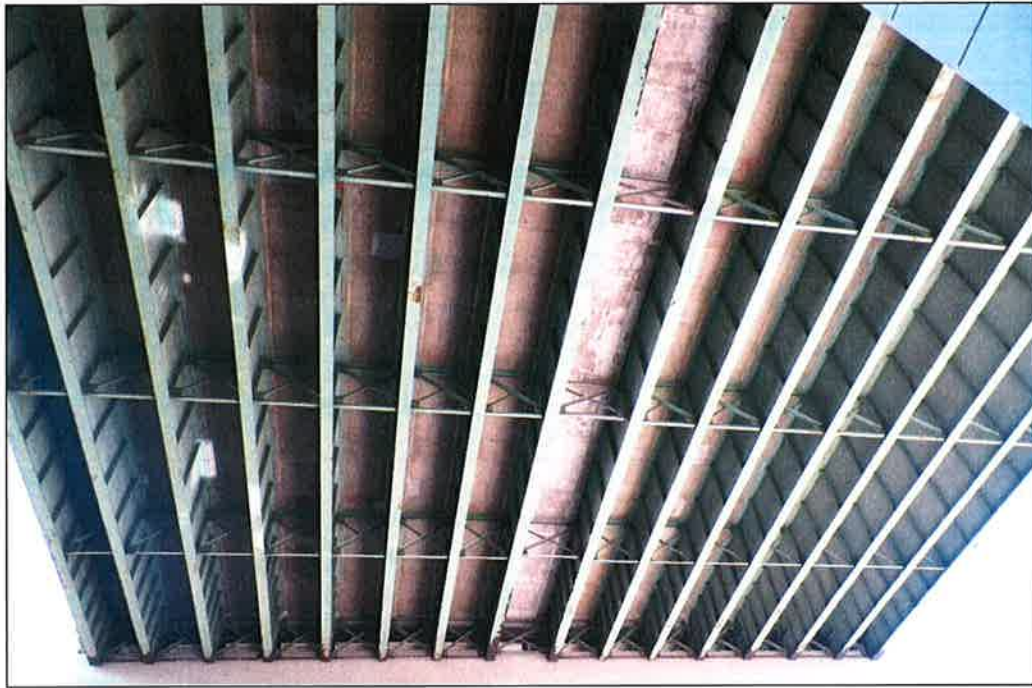
Photo P3 – Typical Condition of Soffit (Bent 53-55) (fair condition – stained and unstained cracking, delaminations, isolated spalls, patches, wet areas and light scaling)

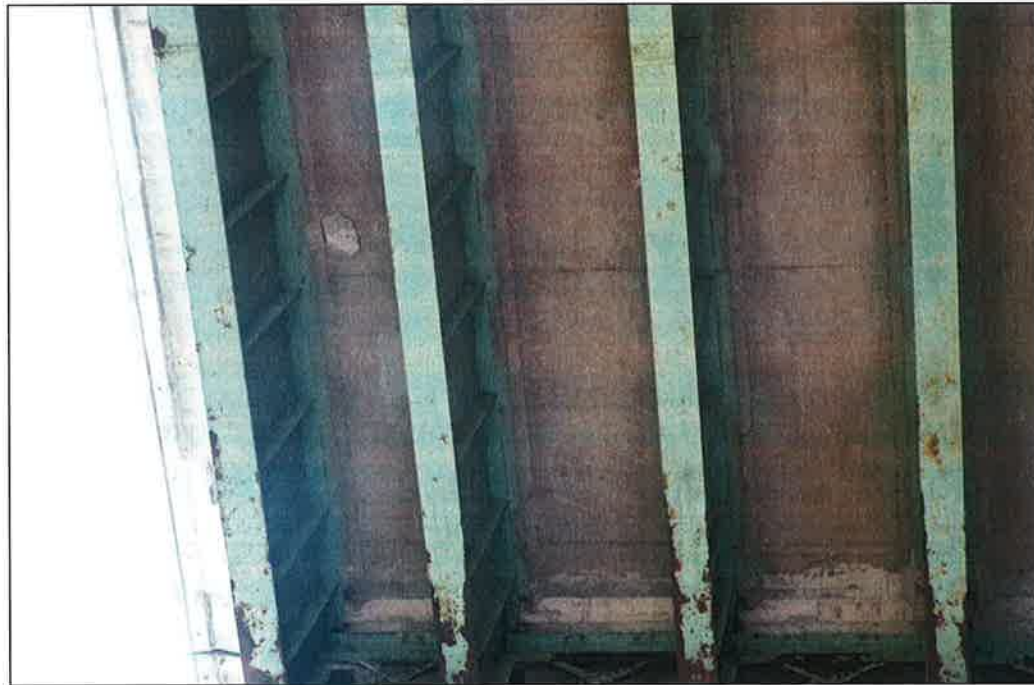
Photo P4 – Typical Condition of Soffit (Bent 53-55) (fair condition – stained and unstained cracking, delaminations, isolated spalls, patches, wet areas and light scaling)

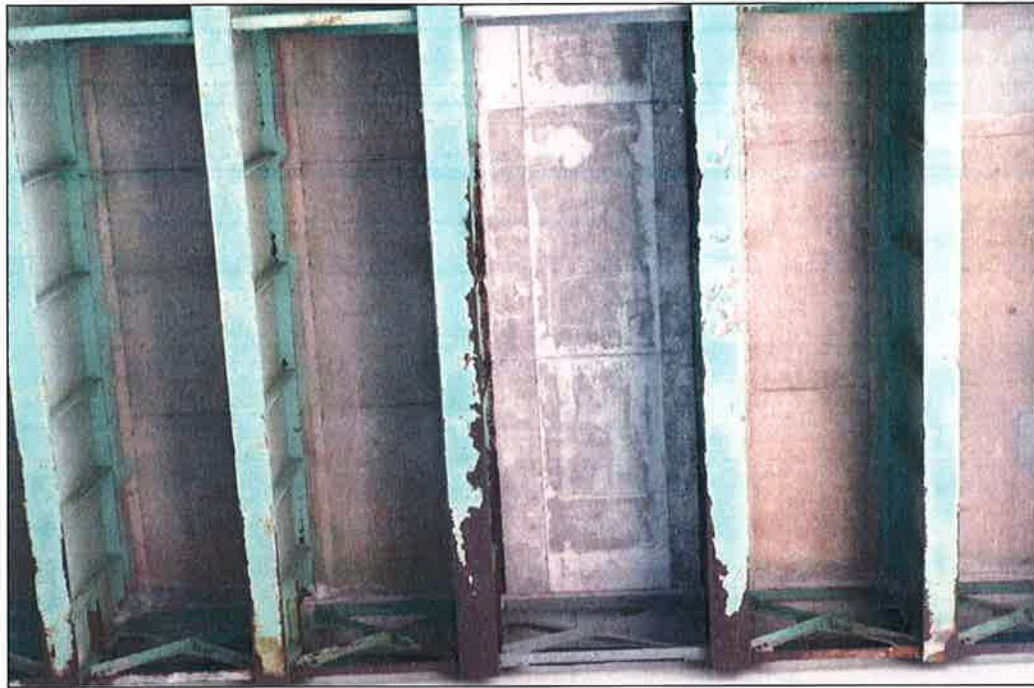
Photo P5 – Typical Condition of Soffit (Bent 53-55) (fair condition – stained and unstained cracking, delaminations, isolated spalls, patches, wet areas and light scaling)

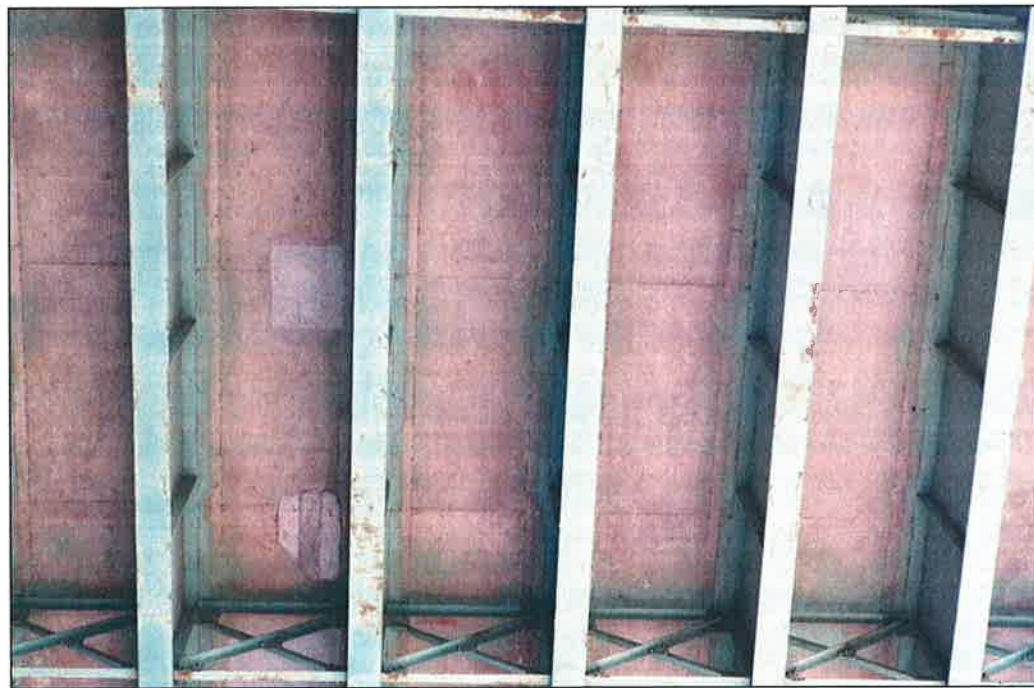
Photo P6 – Typical Condition of Soffit (Bent 53-55) (fair condition – stained and unstained cracking, delaminations, isolated spalls, patches, wet areas and light scaling)

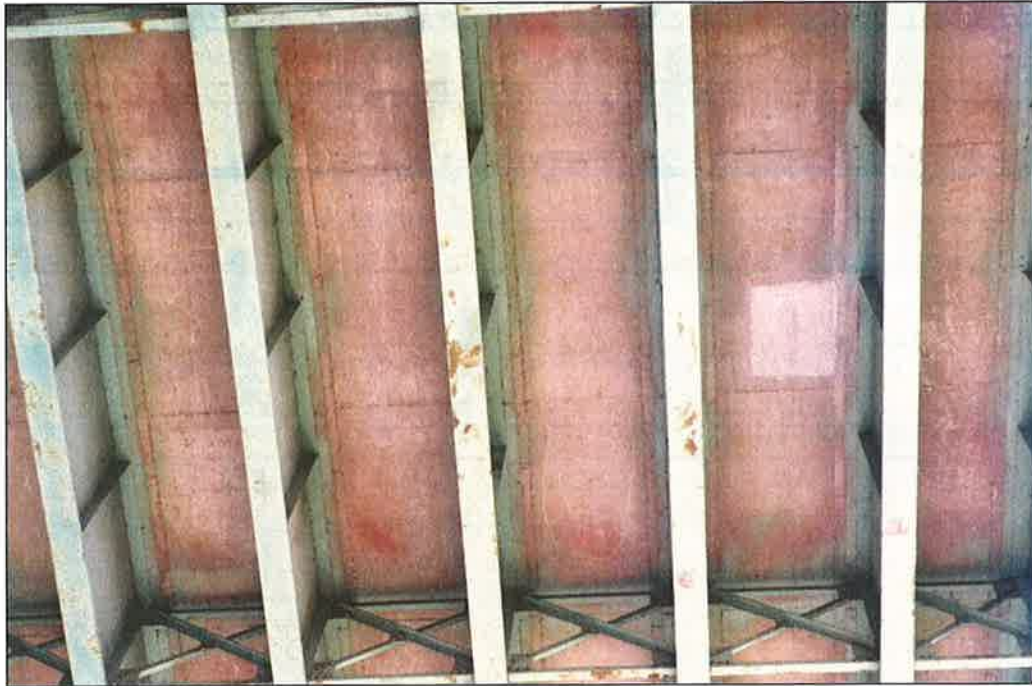
Photo P7 – Typical Condition of Soffit (Bent 53-55) (fair condition – stained and unstained cracking, delaminations, isolated spalls, patches, wet areas and light scaling)

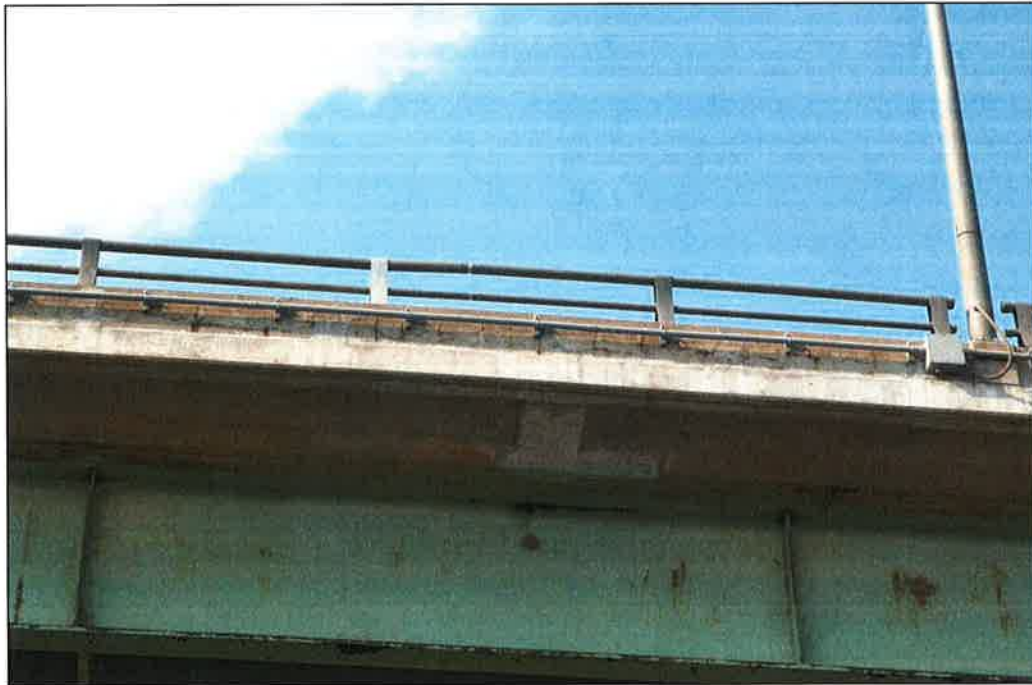
Photo P8 – Typical Condition of Fascia (Bent 53-55) (fair condition –cracking and patches)

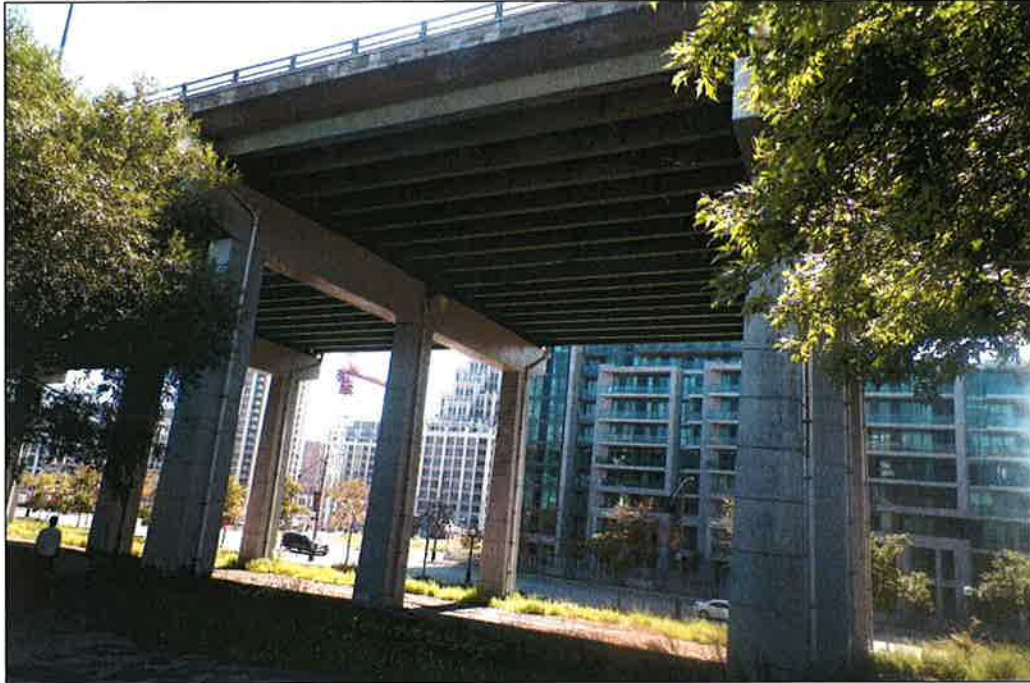
Photo P9 – Elevation (Bent 85-86) (fair condition – stained and unstained cracking, delaminations and patches)

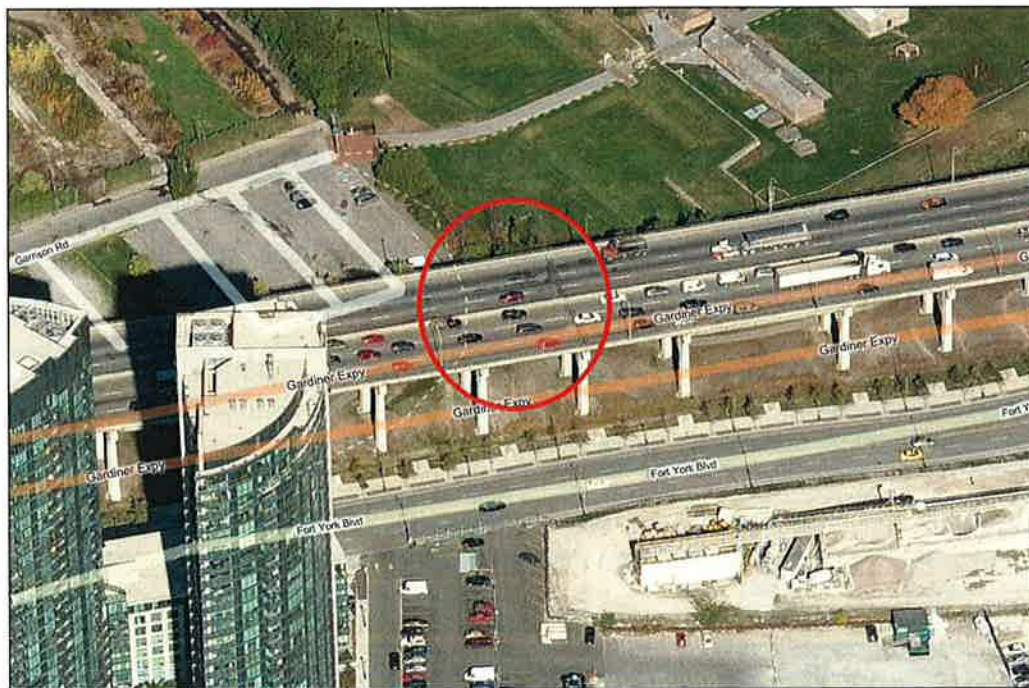
Photo P10 – Aerial Overview of Structure (Bent 85-86) (fair condition – stained and unstained cracking, delaminations and patches)

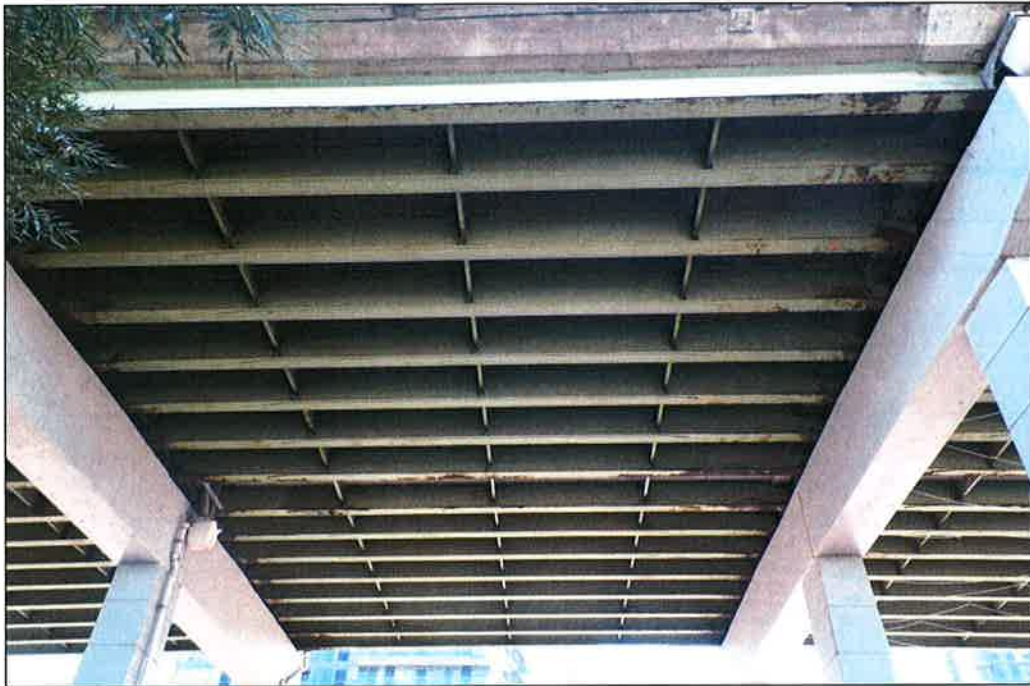
Photo P11 – Typical Condition of Soffit (Bent 85-86) (fair condition – stained and unstained cracking, delaminations and patches)

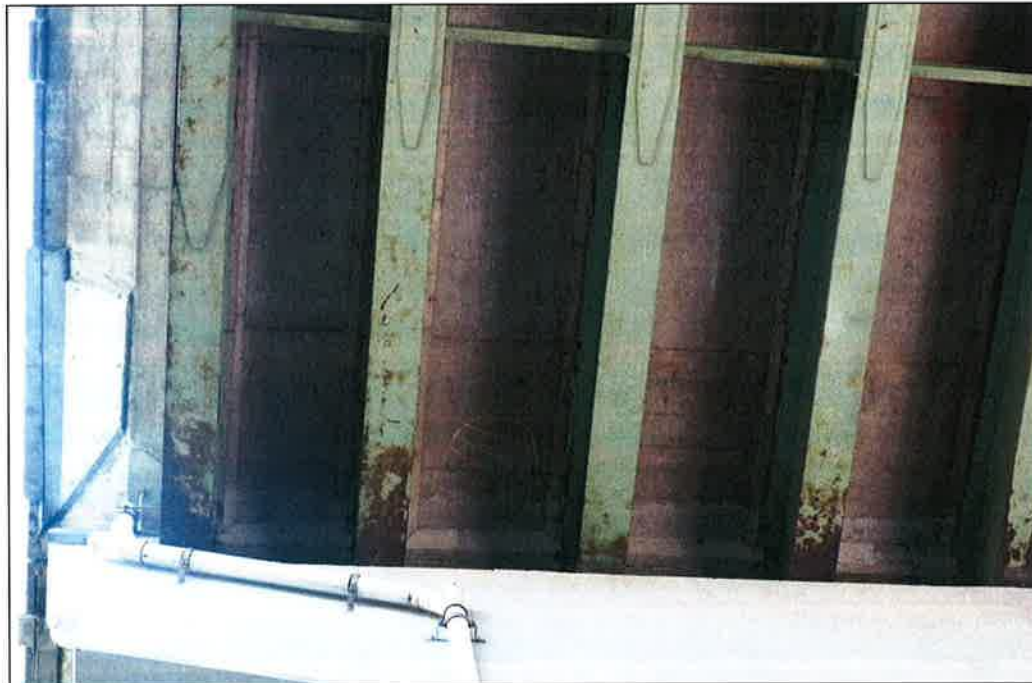
Photo P12 – Typical Condition of Soffit (Bent 85-86) (fair condition – stained and unstained cracking, delaminations and patches)

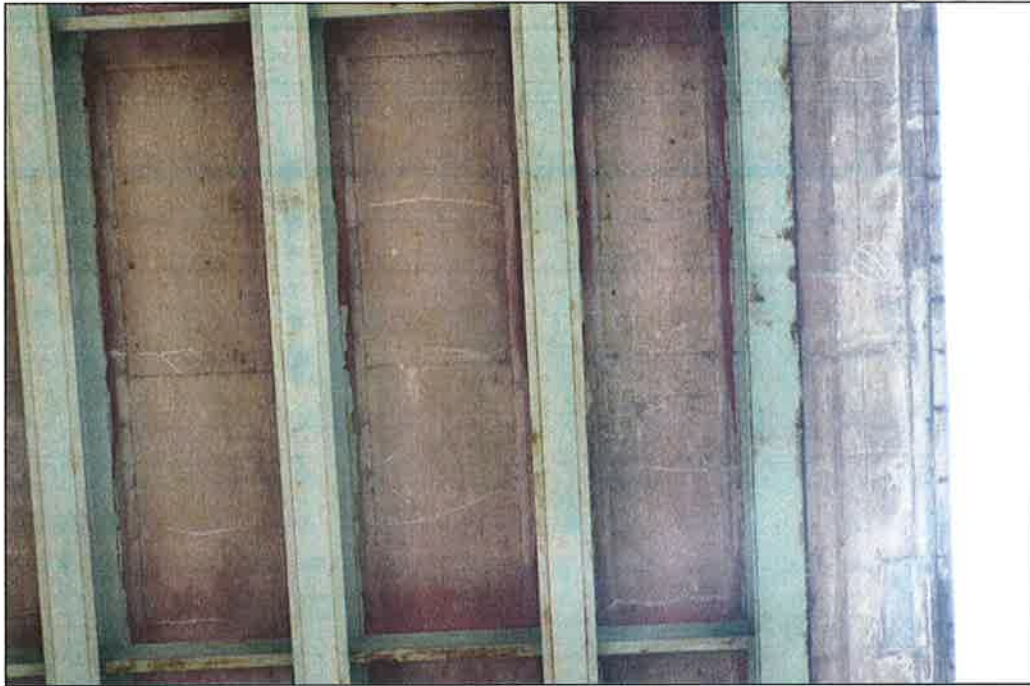
Photo P13 – Typical Condition of Soffit (Bent 85-86) (fair condition – stained and unstained cracking, delaminations and patches)

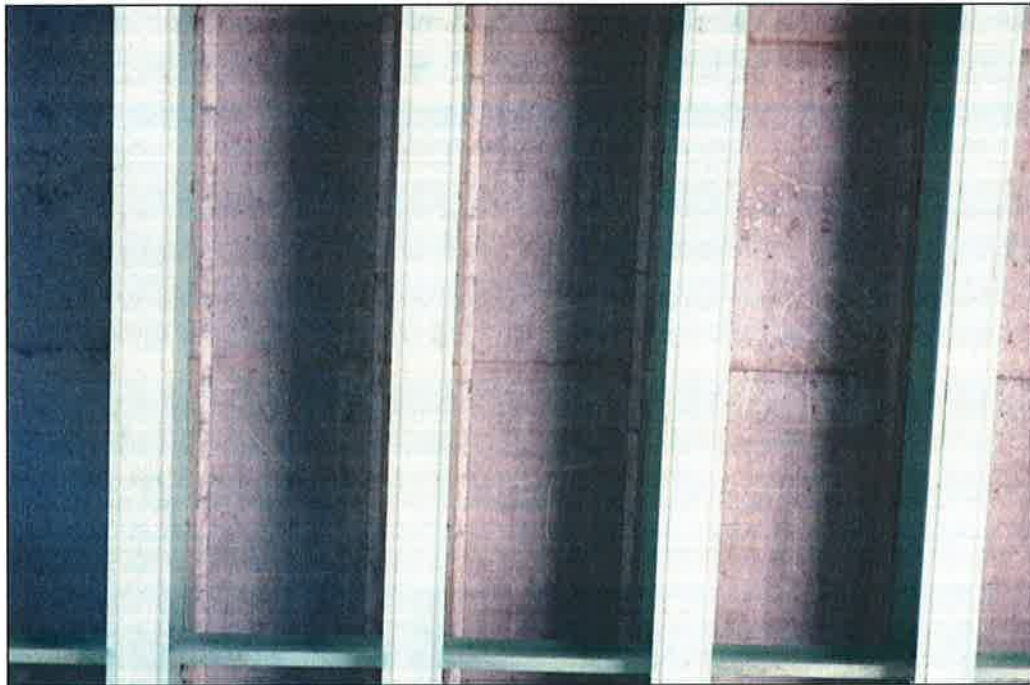
Photo P14 – Typical Condition of Soffit (Bent 85-86) (fair condition – stained and unstained cracking, delaminations and patches)

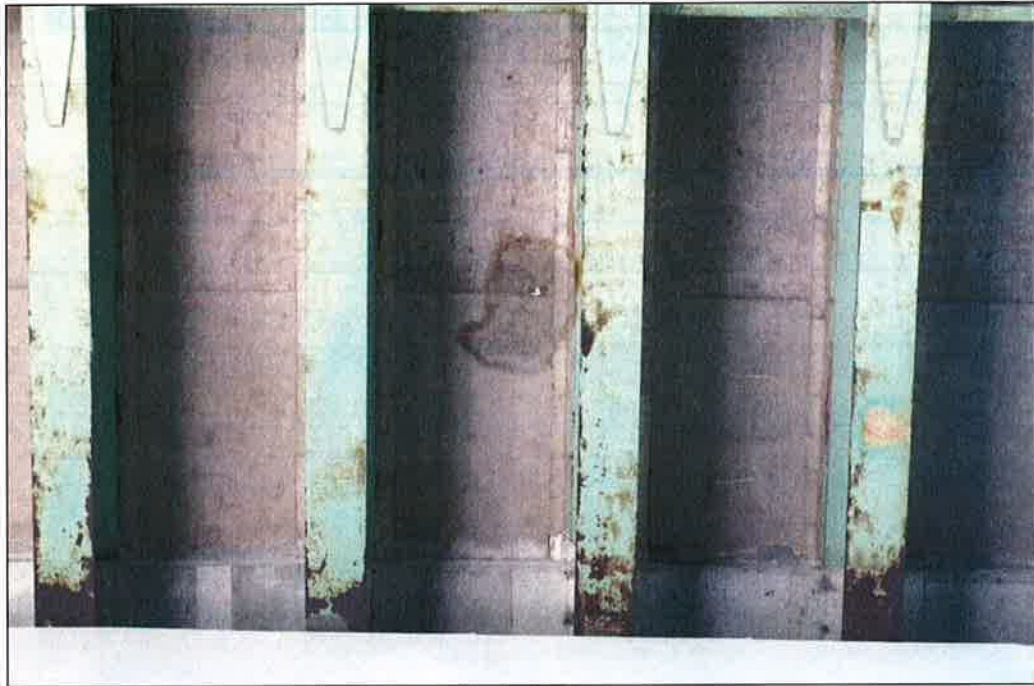
Photo P15 – Typical Condition of Soffit (Bent 85-86) (fair condition – stained and unstained cracking, delaminations and patches)

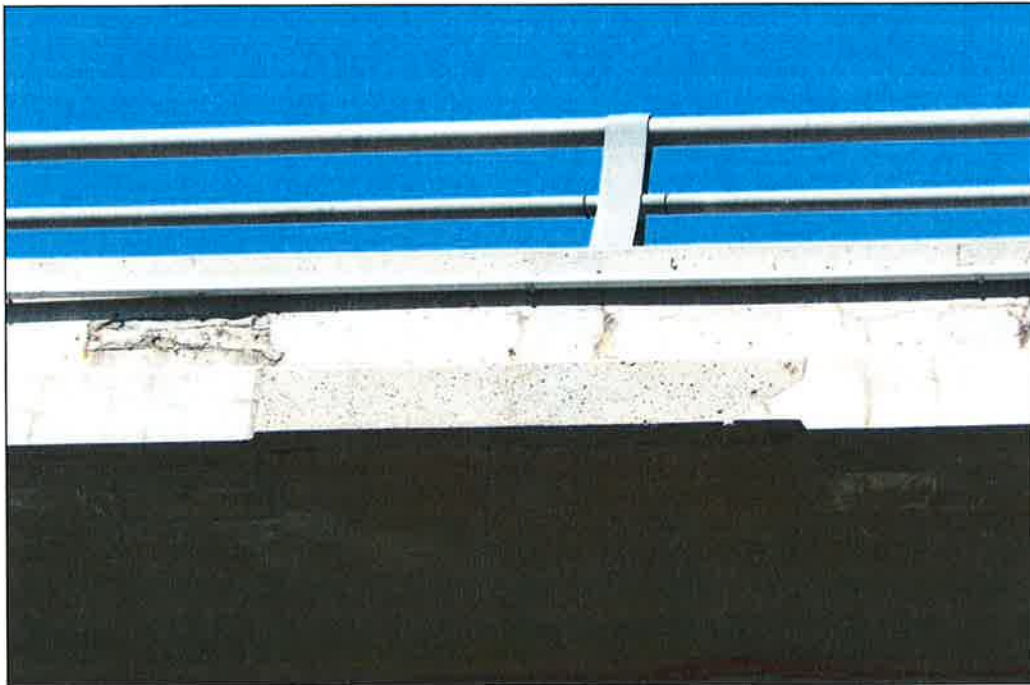
Photo P16 – Typical Condition of Fascia (Bent 85-86) (fair condition –cracking, isolated delaminations and patches)

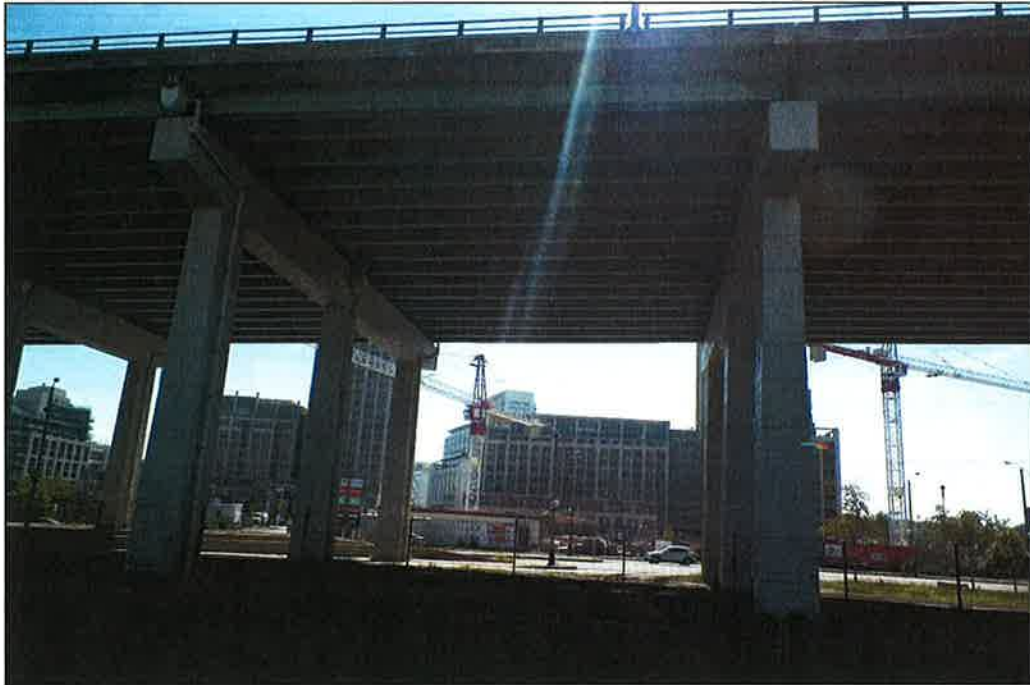
Photo P17 – Elevation (Bent 91-92) (fair condition – stained and unstained cracking, delaminations, isolated spalls, patches, wet areas and light scaling)

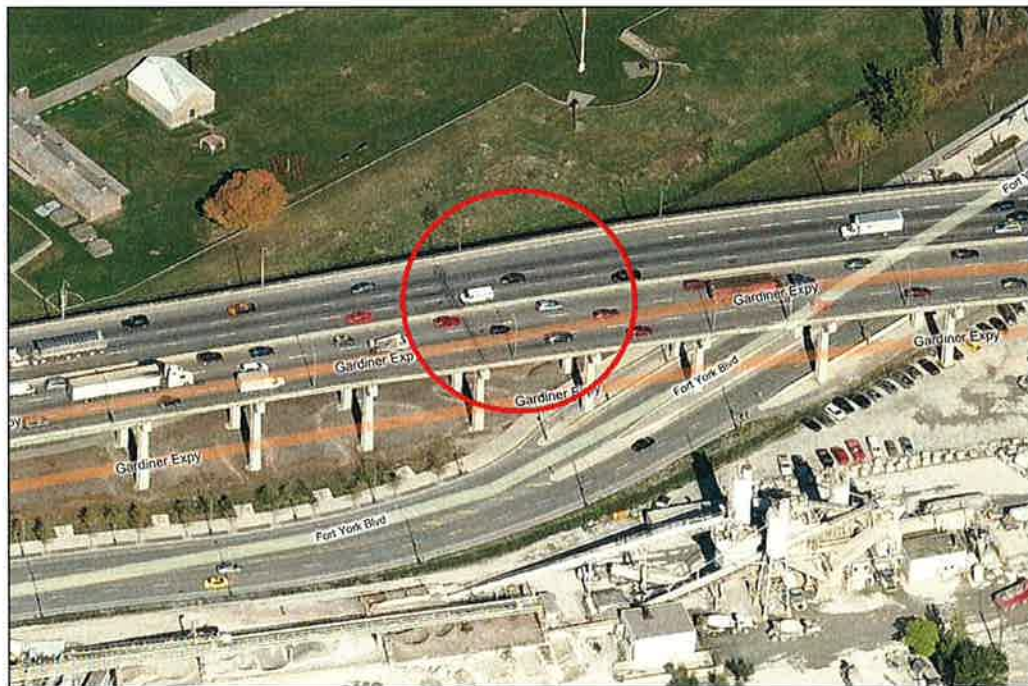
Photo P18 – Aerial Overview of Structure (Bent 91-92) (fair condition – stained and unstained cracking, delaminations, isolated spalls, patches, wet areas and light scaling)

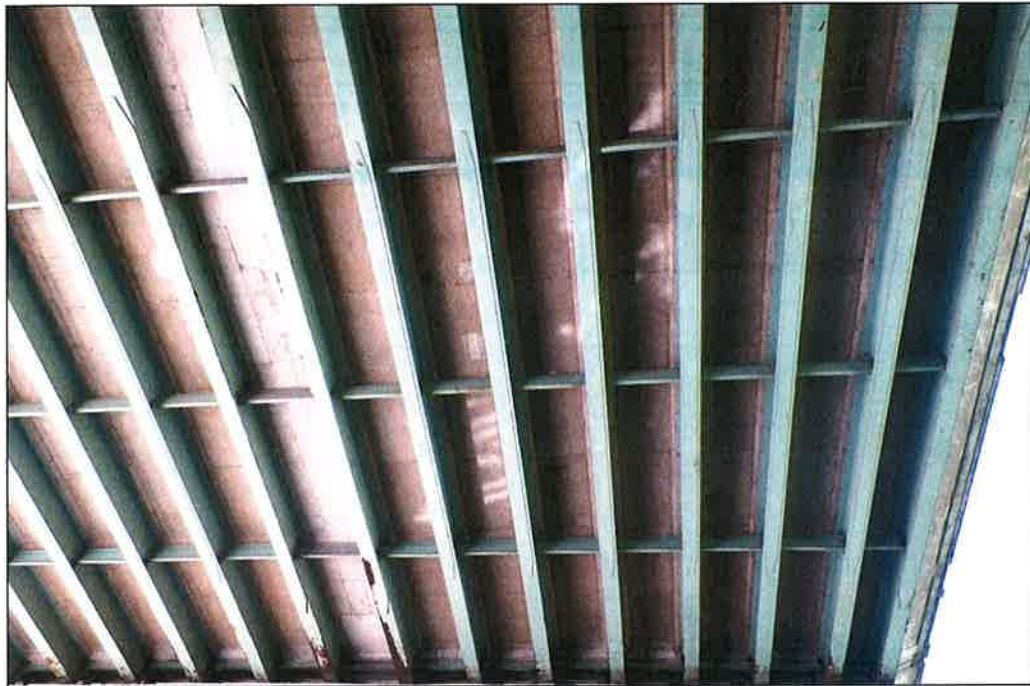
Photo P19 – Typical Condition of Soffit (Bent 91-92) (fair condition – stained and unstained cracking, delaminations, isolated spalls, patches, wet areas and light scaling)

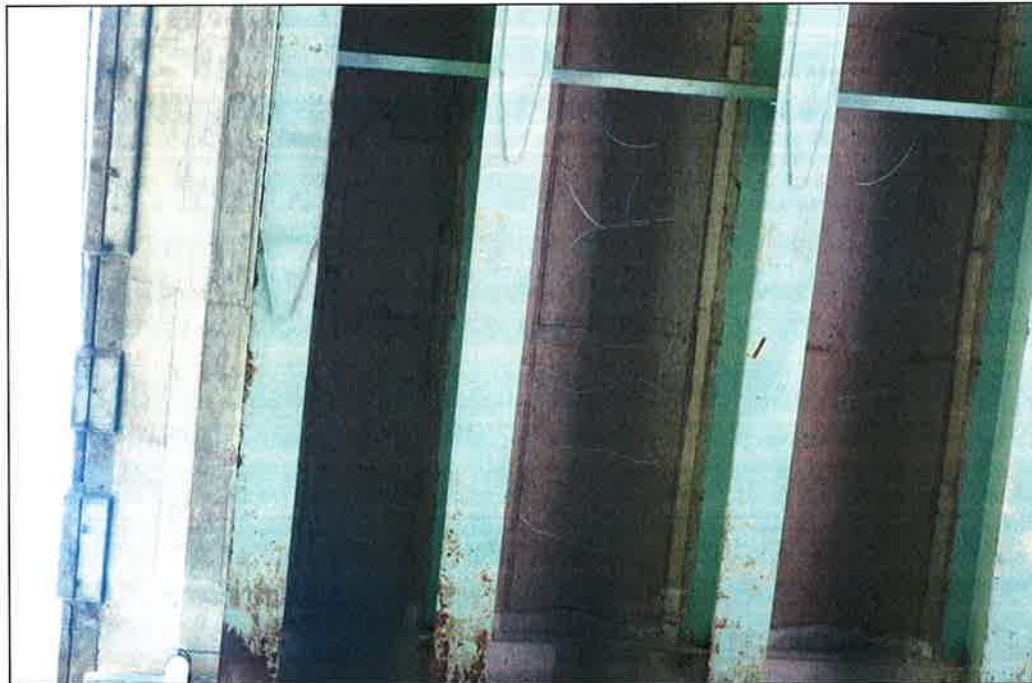
Photo P20 – Typical Condition of Soffit (Bent 91-92) (fair condition – stained and unstained cracking, delaminations, isolated spalls, patches, wet areas and light scaling)

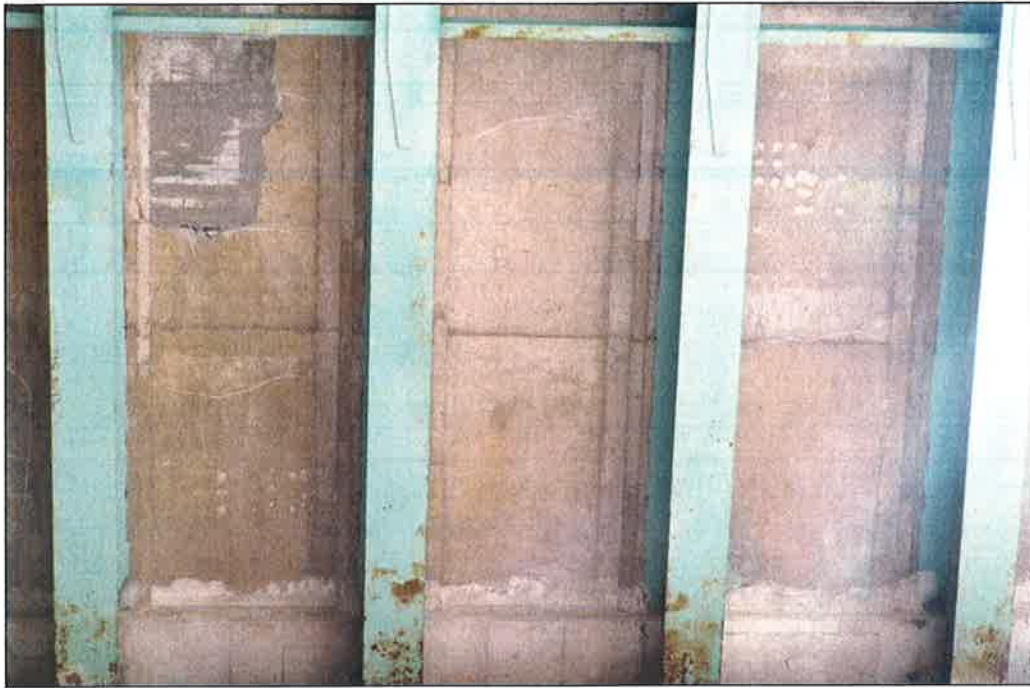
Photo P21 – Typical Condition of Soffit (Bent 91-92) (fair condition – stained and unstained cracking, delaminations, isolated spalls, patches, wet areas and light scaling)

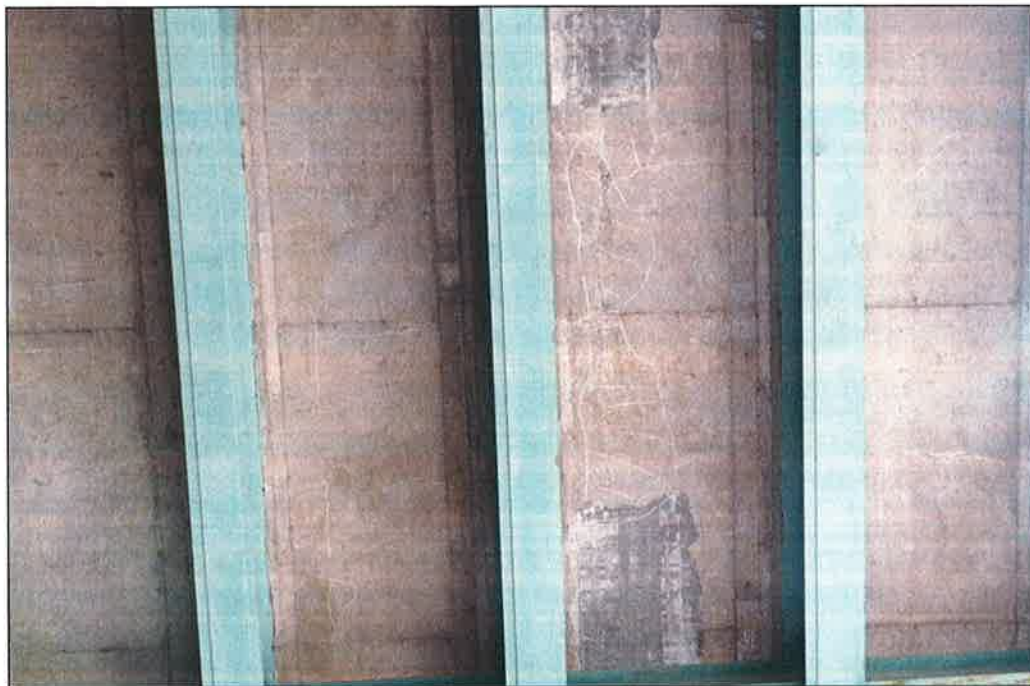
Photo P22 – Typical Condition of Soffit (Bent 91-92) (fair condition – stained and unstained cracking, delaminations, isolated spalls, patches, wet areas and light scaling)

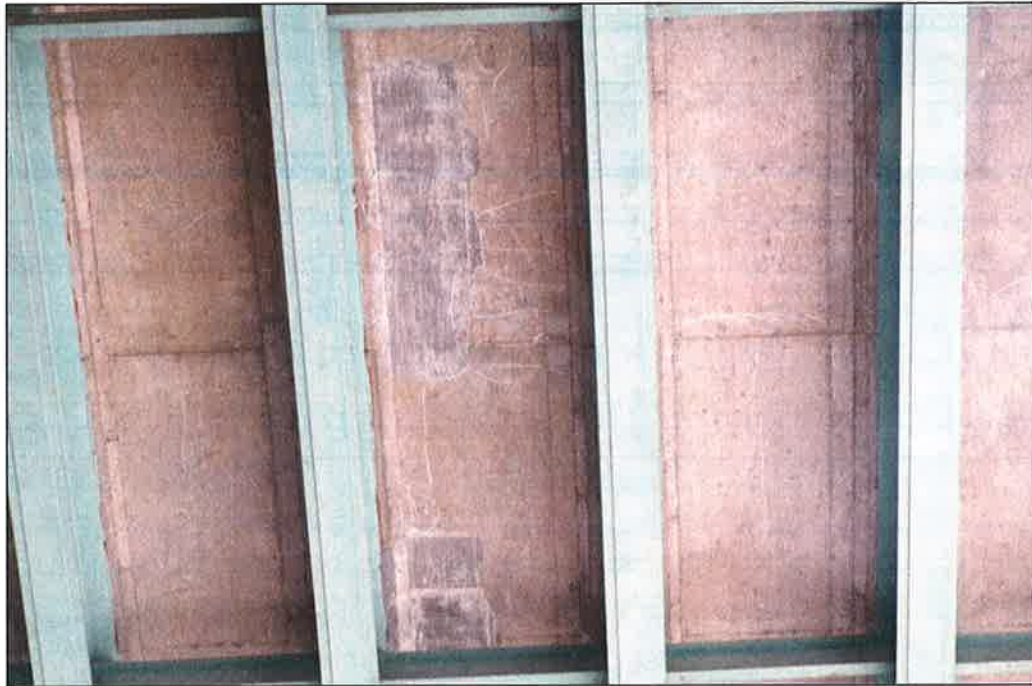
Photo P23 – Typical Condition of Soffit (Bent 91-92) (fair condition – stained and unstained cracking, delaminations, isolated spalls, patches, wet areas and light scaling)

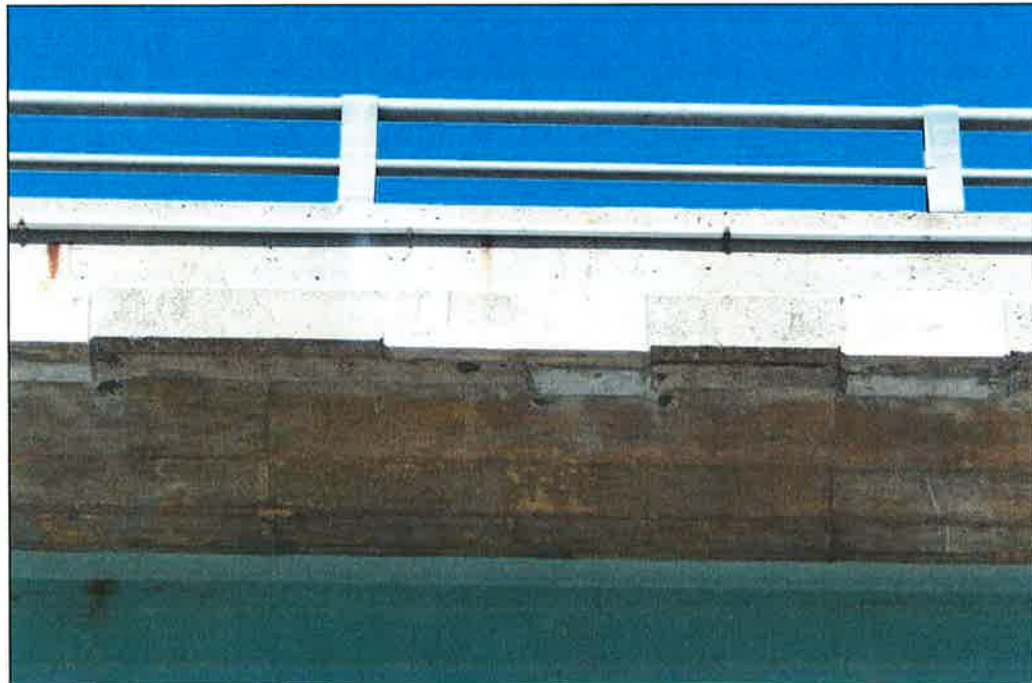
Photo P24 – Typical Condition of Fascia (Bent 91-92) (fair condition – cracking, isolated spalls and patches)

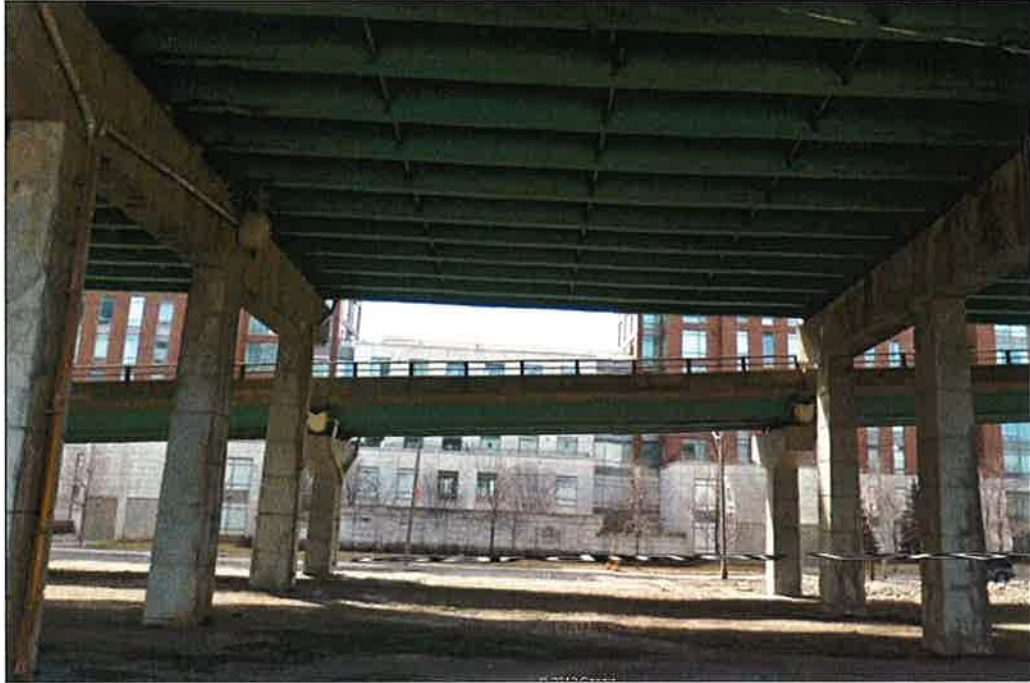
Photo P25 – Elevation (Bent 120-121) (fair condition – stained and unstained cracking, isolated delaminations and spalls, patches and light scaling)

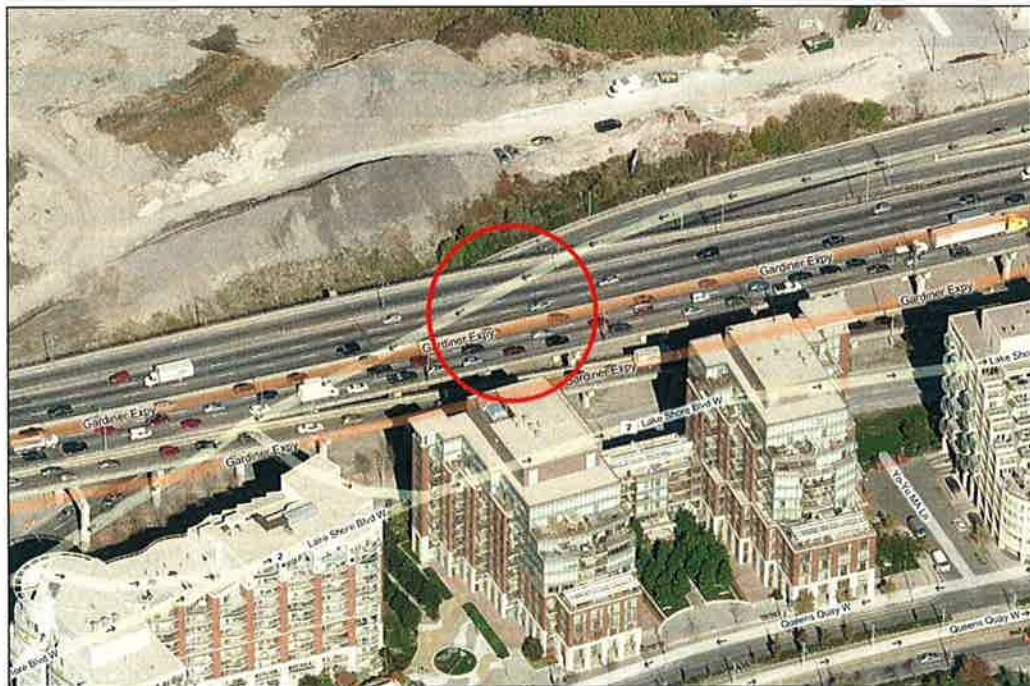
Photo P26 – Aerial Overview of Structure (Bent 120-121) (fair condition – stained and unstained cracking, isolated delaminations and spalls, patches and light scaling)

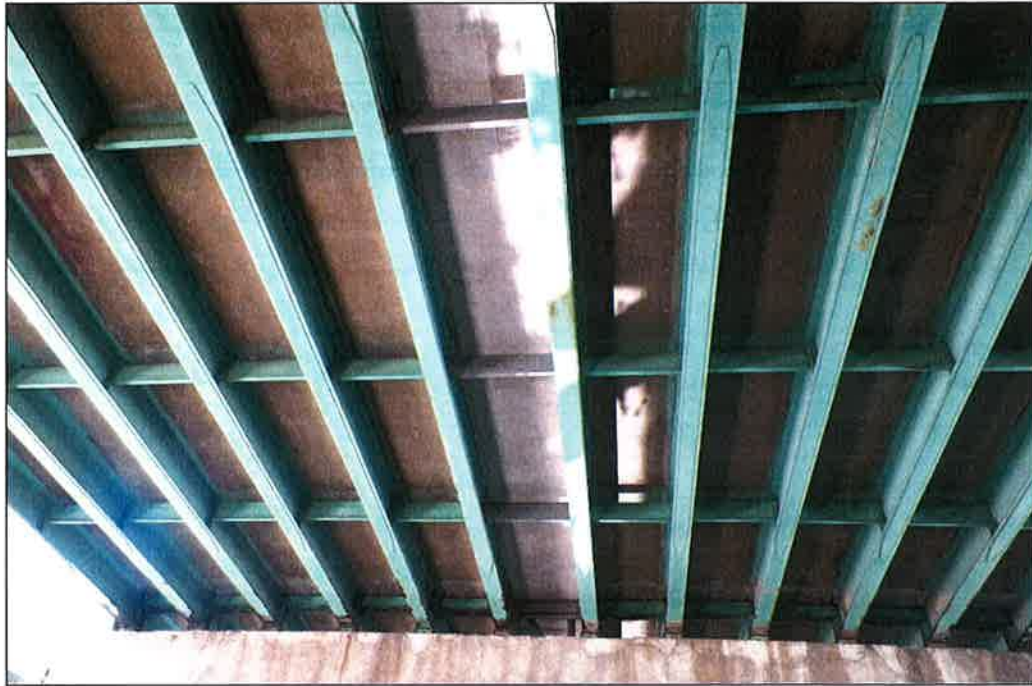
Photo P27 – Typical Condition of Soffit (Bent 120-121) (fair condition – stained and unstained cracking, isolated delaminations and spalls, patches and light scaling)

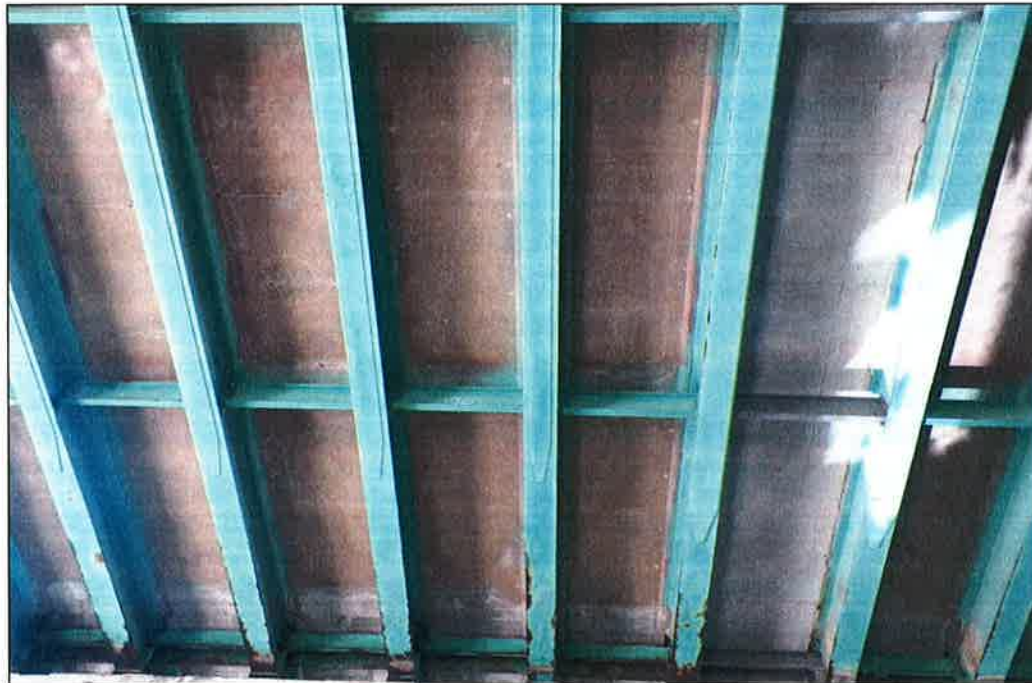
Photo P28 – Typical Condition of Soffit (Bent 120-121) (fair condition – stained and unstained cracking, isolated delaminations and spalls, patches and light scaling)

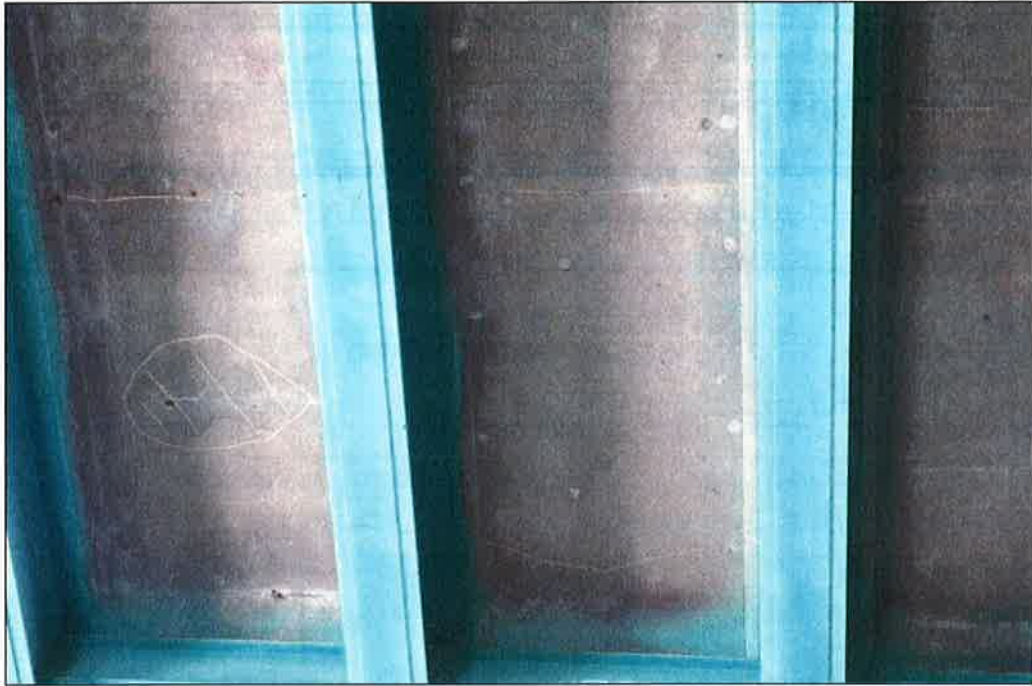
Photo P29 – Typical Condition of Soffit (Bent 120-121) (fair condition – stained and unstained cracking, isolated delaminations and spalls, patches and light scaling)

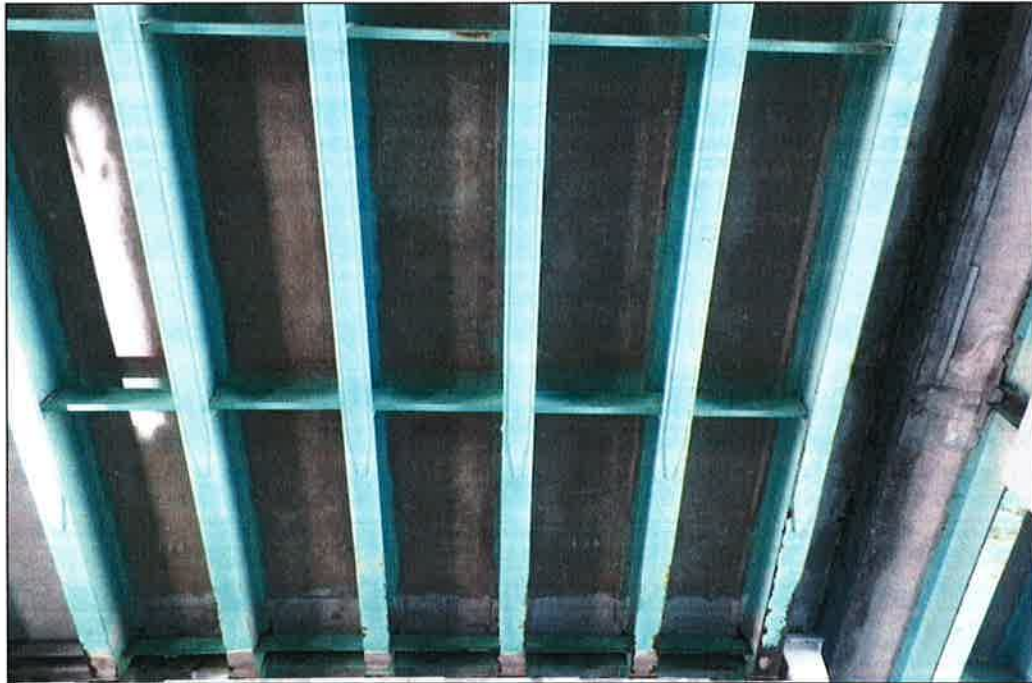
Photo P30 – Typical Condition of Soffit (Bent 120-121) (fair condition – stained and unstained cracking, isolated delaminations and spalls, patches and light scaling)
