IBI Group
30 International Boulevard
Toronto ON M9W 5P3 Canada
tel 416 679 1930
fax 416 675 4620

September 10, 2012

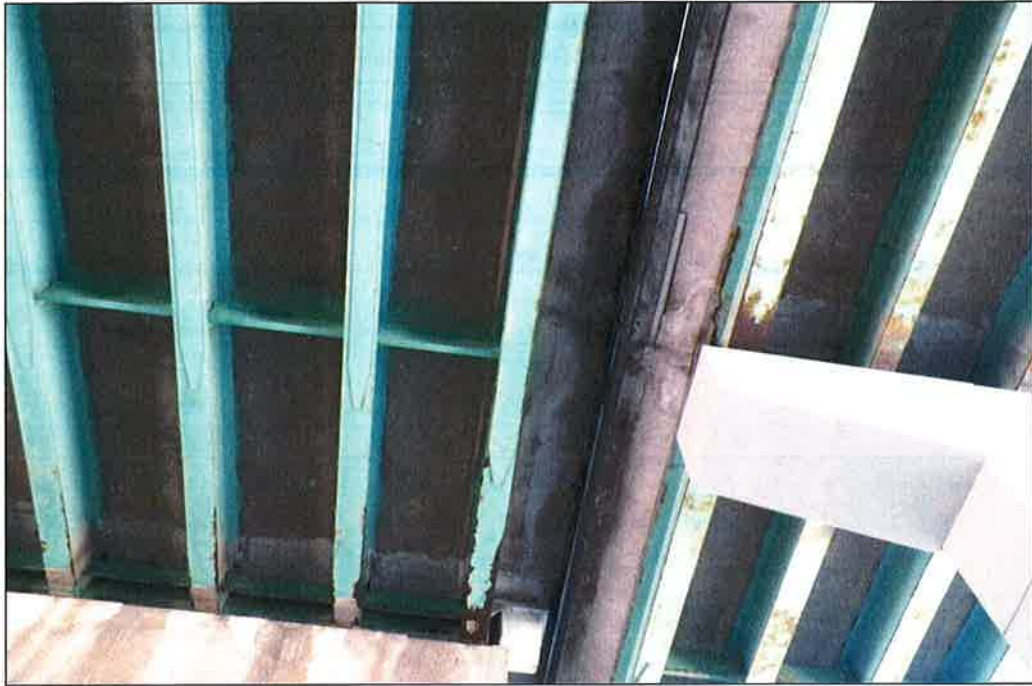
Photo P31 – Typical Condition of Soffit (Bent 120-121) (fair condition – stained and unstained cracking, isolated delaminations and spalls, patches and light scaling)

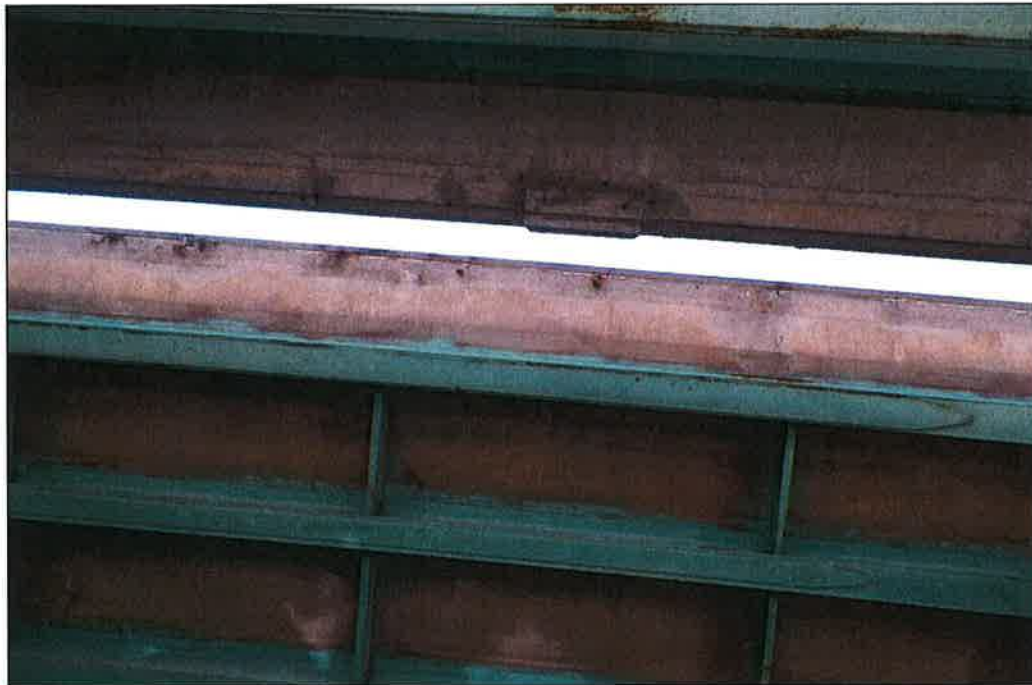
Photo P32 – Typical Condition of Fascia (Bent 120-121)

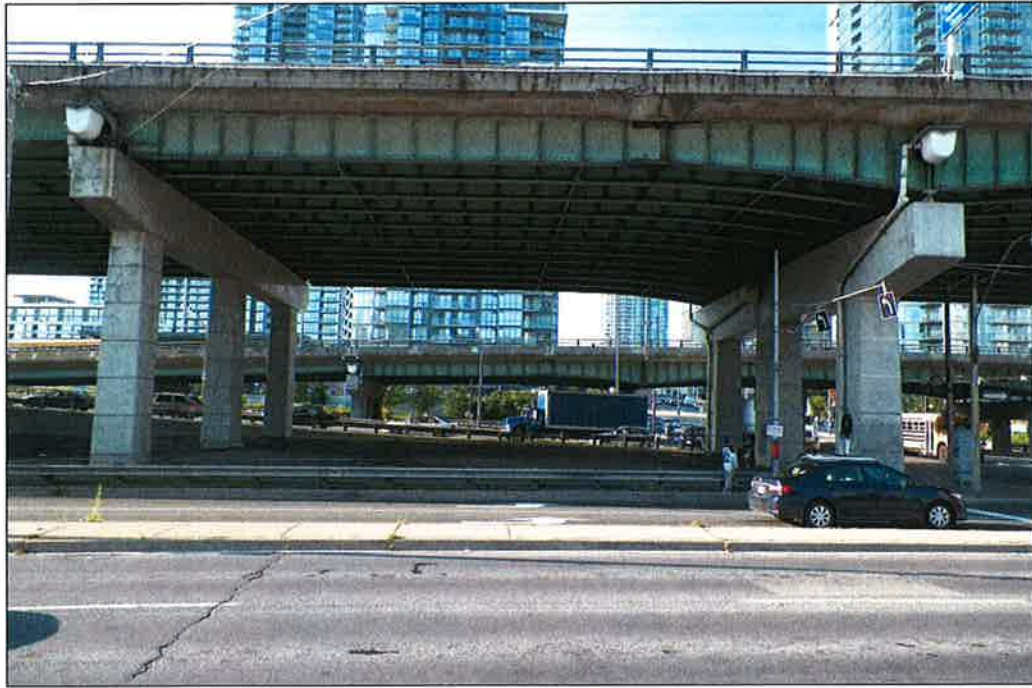
Photo P33 – Elevation (Bent 131-132) (fair condition – stained and unstained cracking, isolated delaminations and spalls, patches and light scaling)

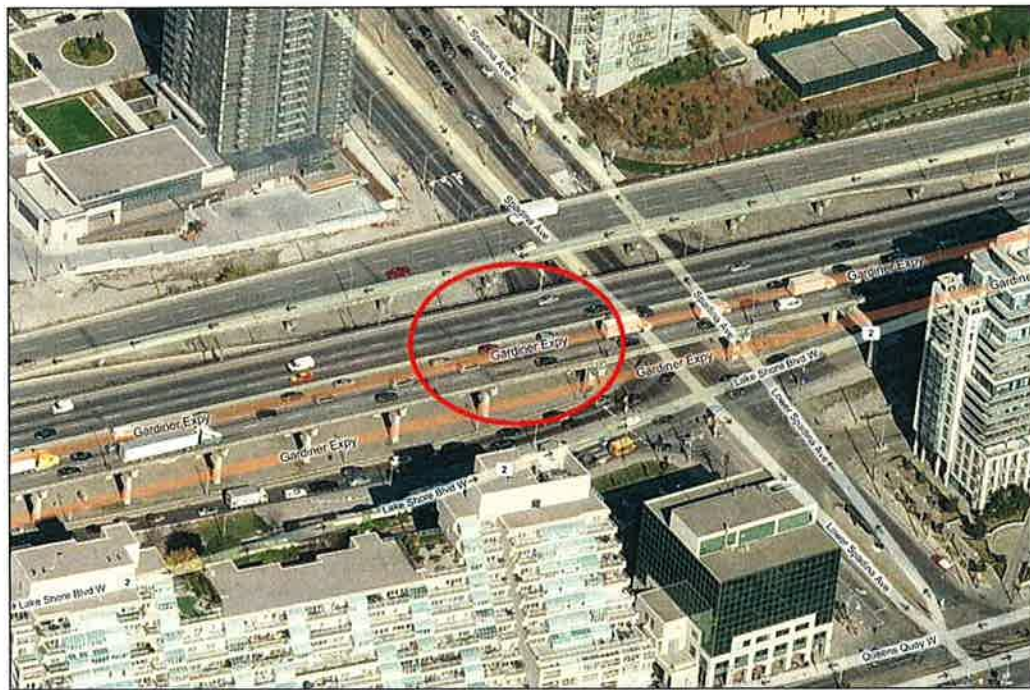
Photo P34 – Aerial Overview of Structure (Bent 131-132) (fair condition – stained and unstained cracking, isolated delaminations and spalls, patches and light scaling)

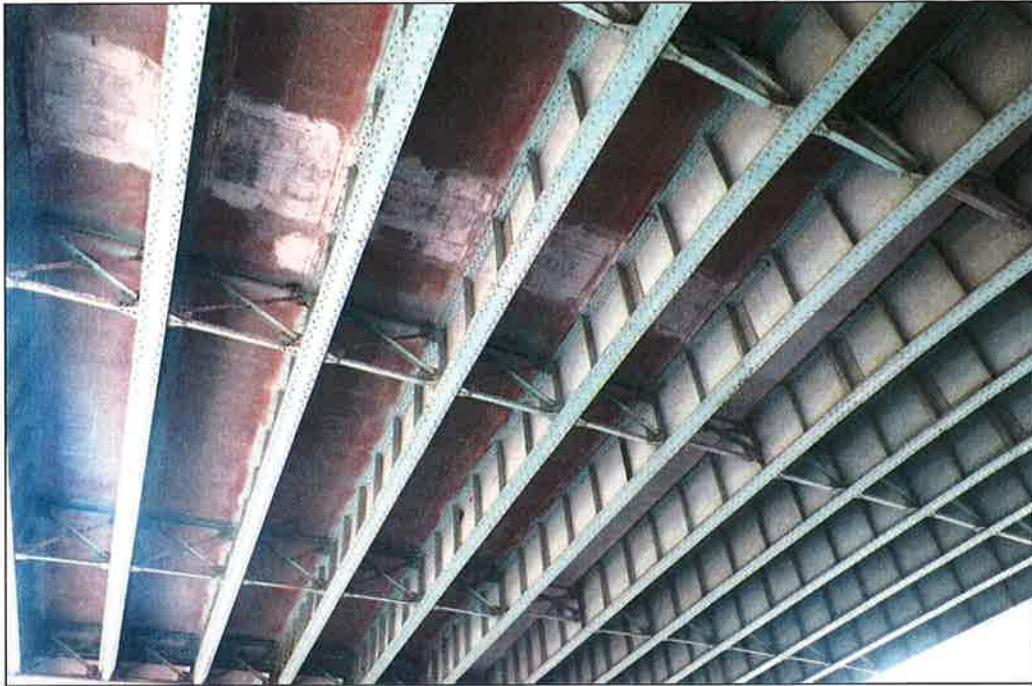
Photo P35 – Typical Condition of Soffit (Bent 131-132) (fair condition – stained and unstained cracking, isolated delaminations and spalls, patches and light scaling)

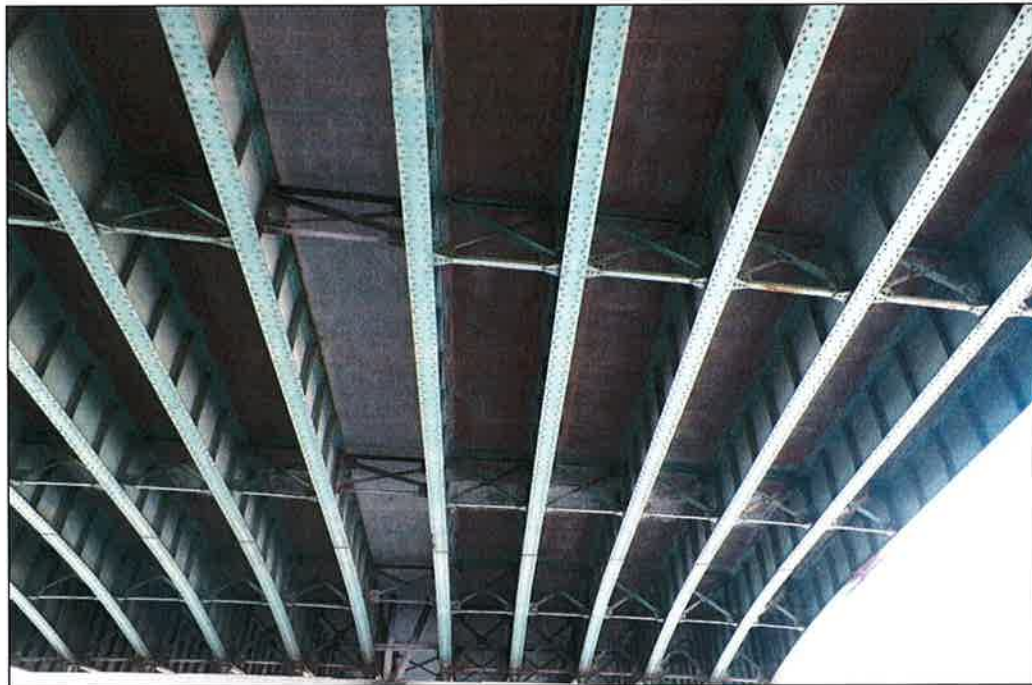
Photo P36 – Typical Condition of Soffit (Bent 131-132) (fair condition – stained and unstained cracking, isolated delaminations and spalls, patches and light scaling)

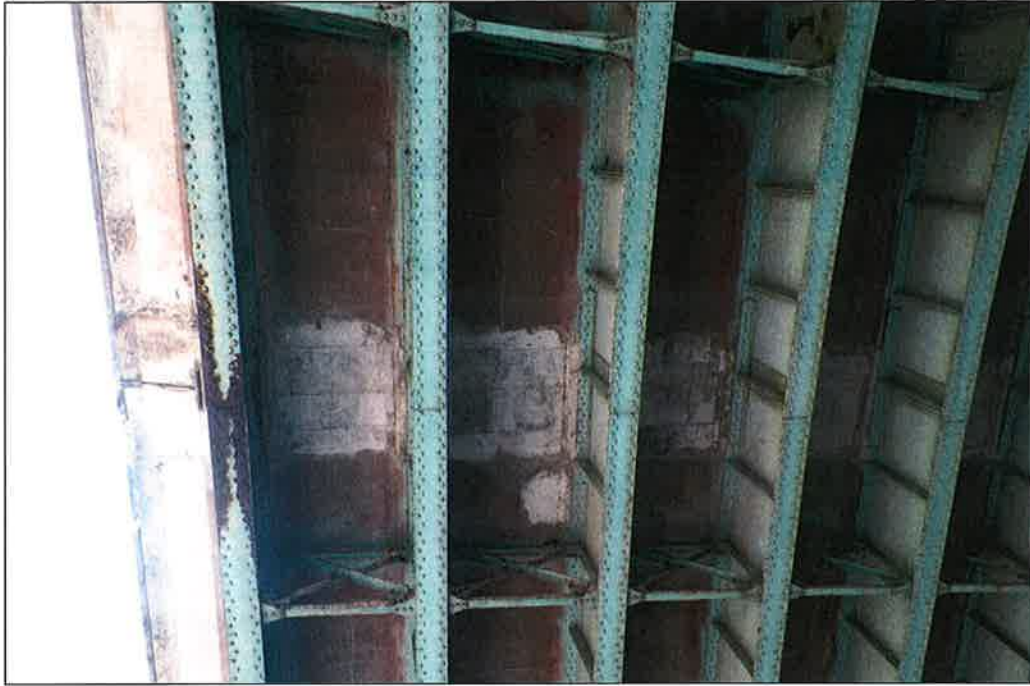
Photo P37 – Typical Condition of Soffit (Bent 131-132) (fair condition – stained and unstained cracking, isolated delaminations and spalls, patches and light scaling)

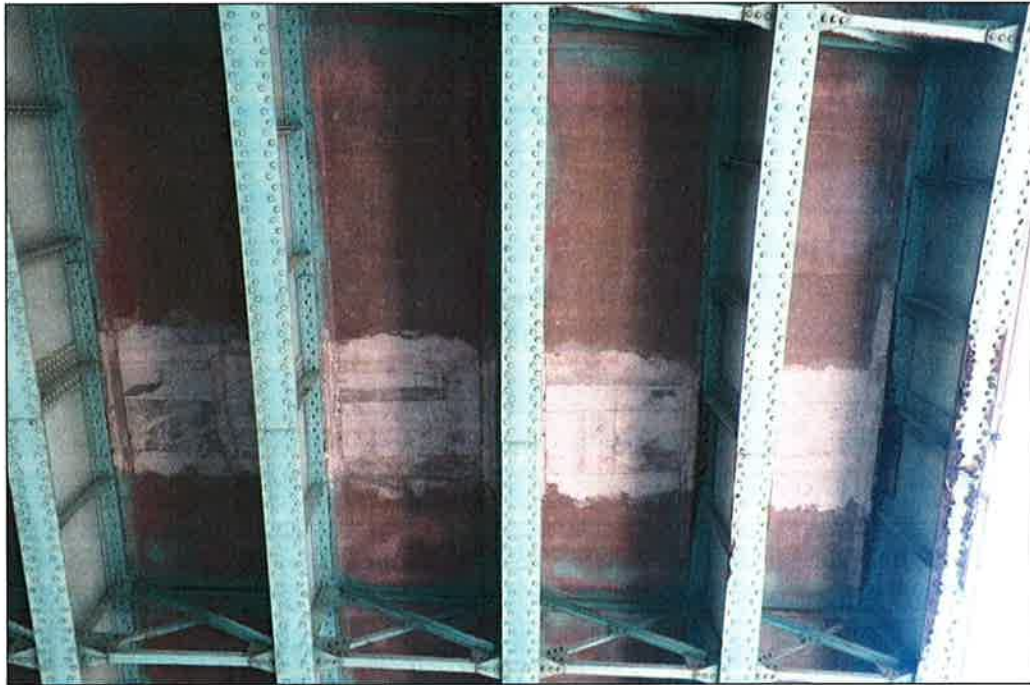
Photo P38 – Typical Condition of Soffit (Bent 131-132) (fair condition – stained and unstained cracking, isolated delaminations and spalls, patches and light scaling)

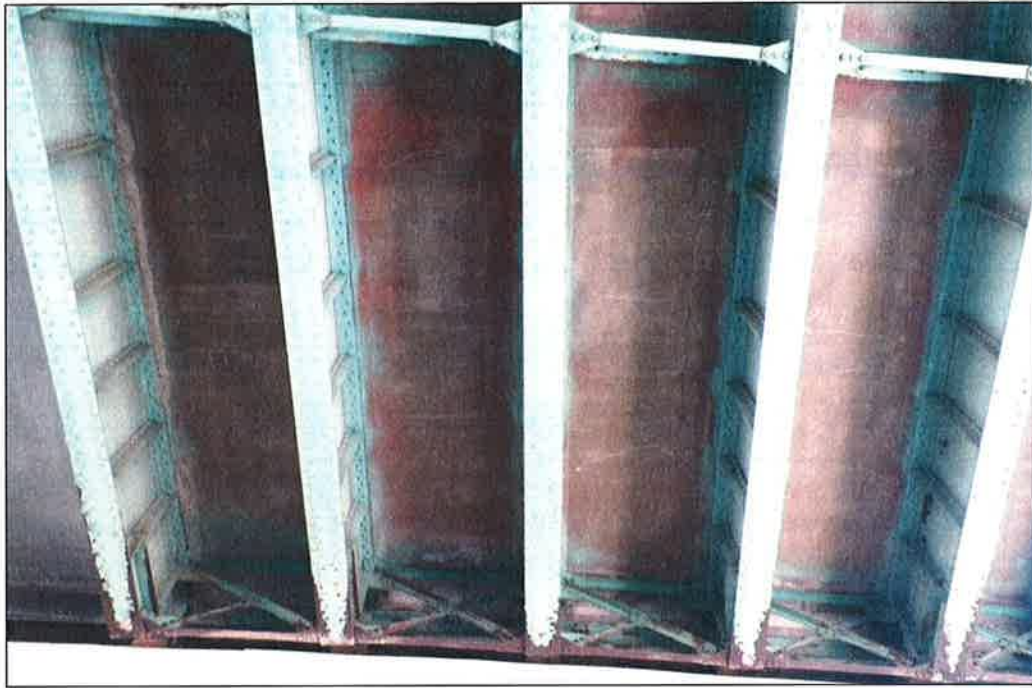
Photo P39 – Typical Condition of Soffit (Bent 131-132) (fair condition – stained and unstained cracking, isolated delaminations and spalls, patches and light scaling)

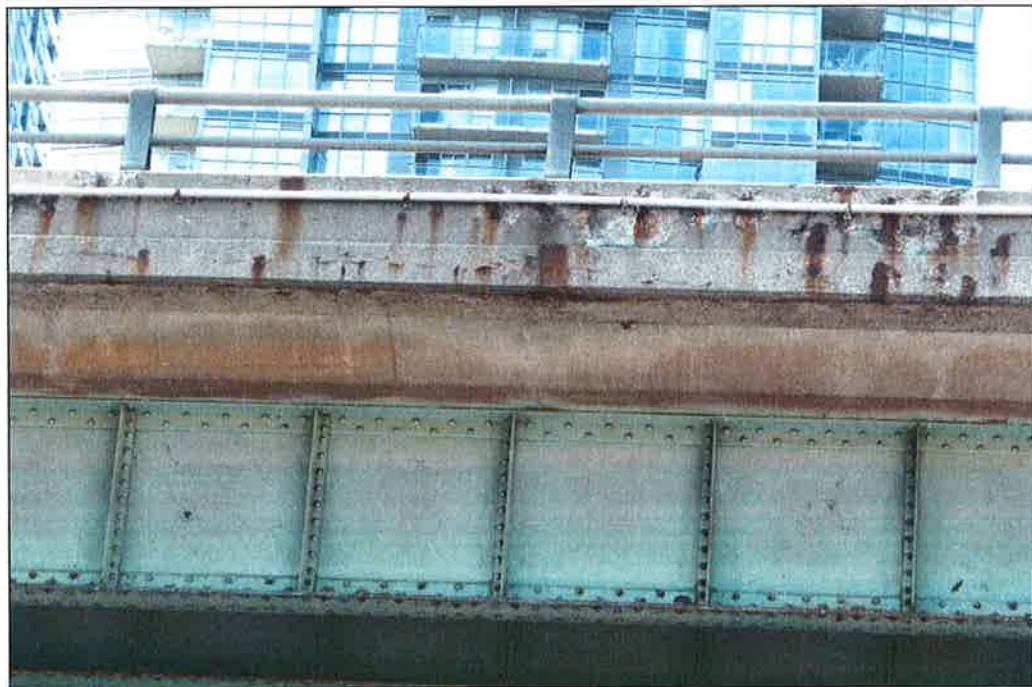
Photo P40 – Typical Condition of Fascia (Bent 131-132) (poor condition – cracking, delaminations, spalls and isolated patches)

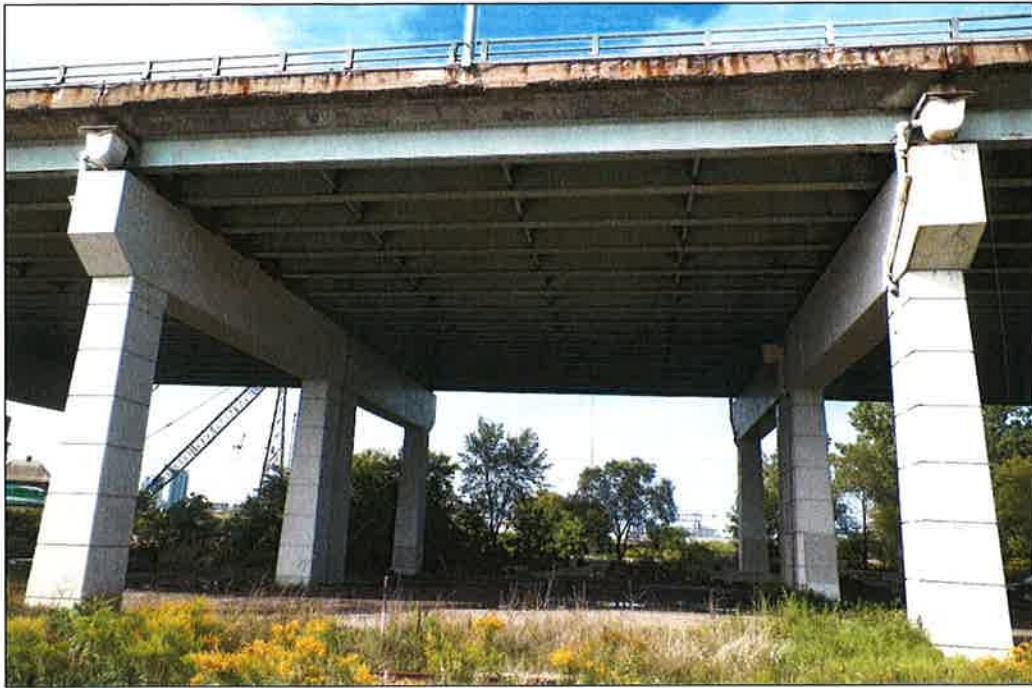
Photo P41 – Elevation (Bent 301-302) (fair-to-poor condition – stained and unstained cracking, delaminations, spalls, patches, wet areas and light scaling)

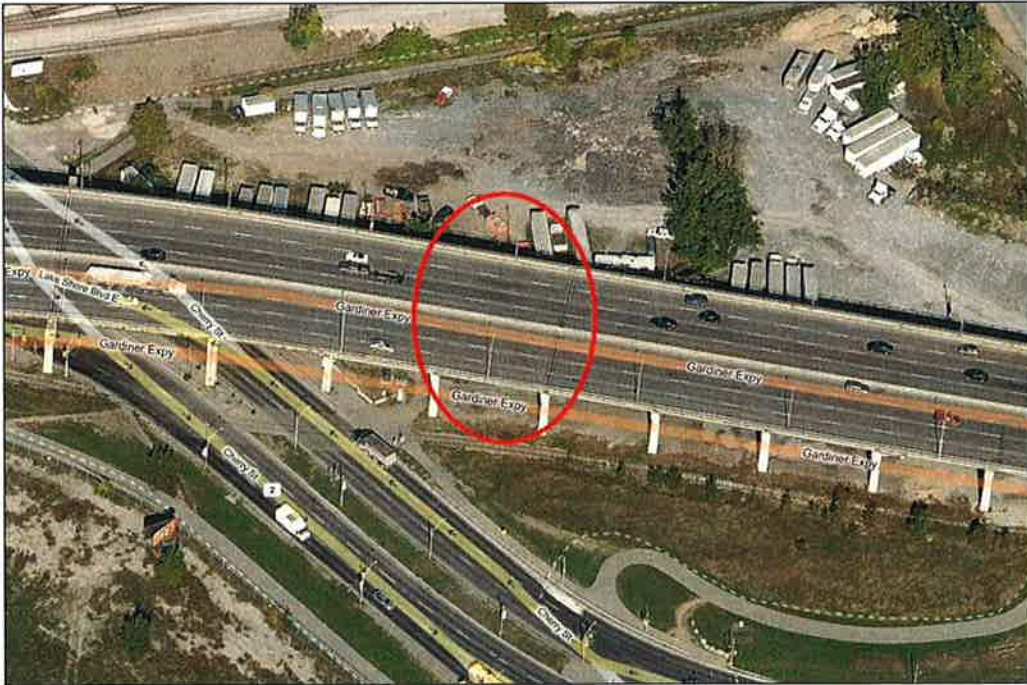
Photo P42 – Aerial Overview of Structure (Bent 301-302) (fair-to-poor condition – stained and unstained cracking, delaminations, spalls, patches, wet areas and light scaling)

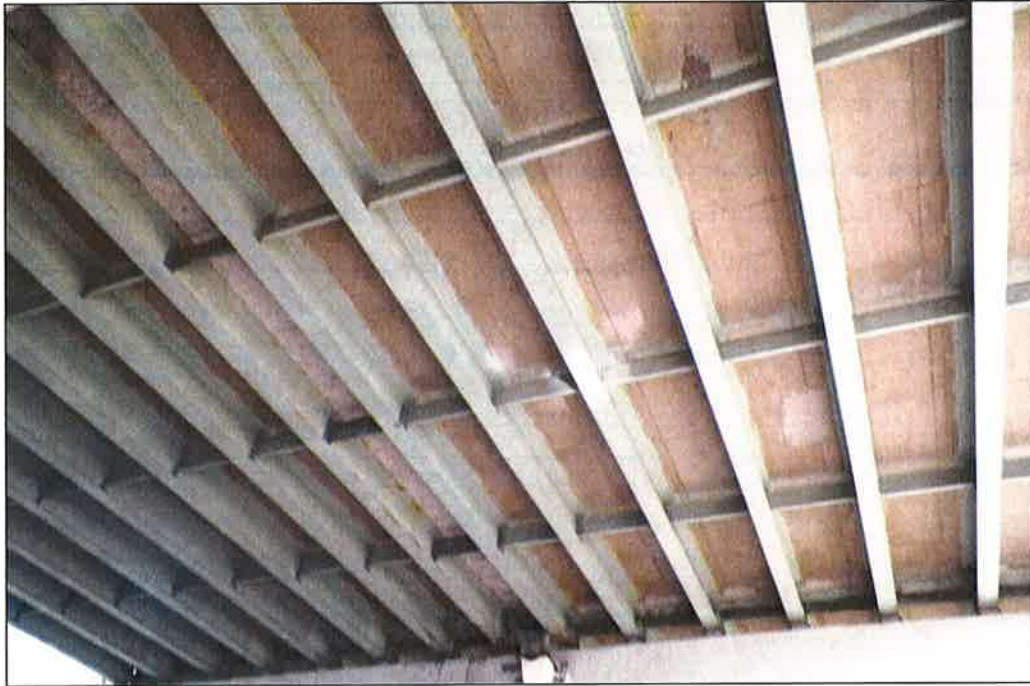
Photo P43 – Typical Condition of Soffit (Bent 301-302) (fair-to-poor condition – stained and unstained cracking, delaminations, spalls, patches, wet areas and light scaling)

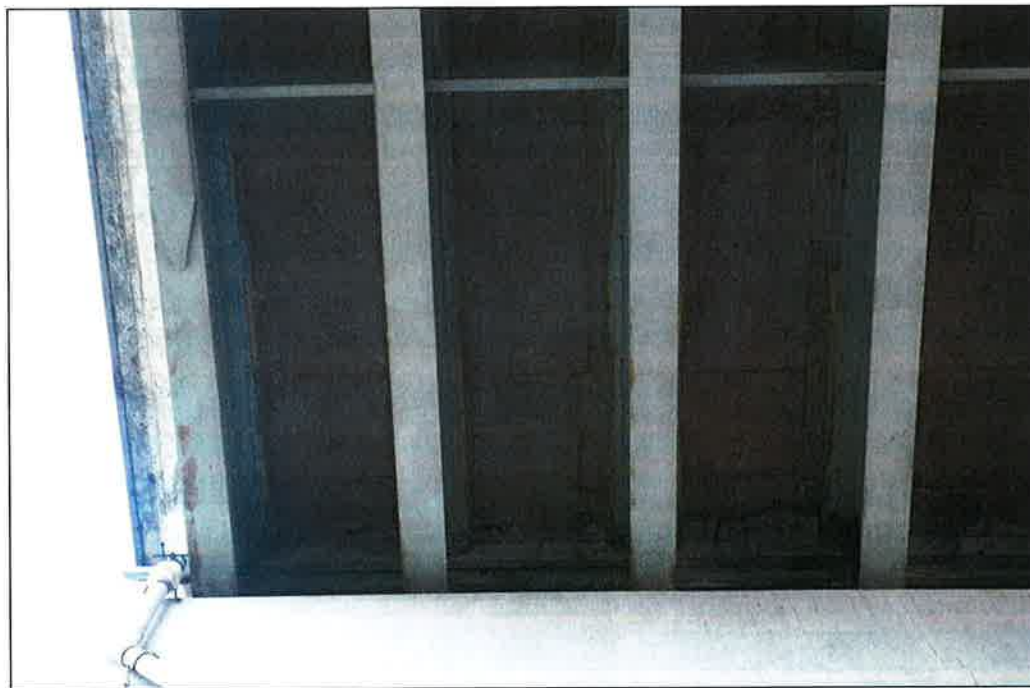
Photo P44 – Typical Condition of Soffit (Bent 301-302) (fair-to-poor condition – stained and unstained cracking, delaminations, spalls, patches, wet areas and light scaling)

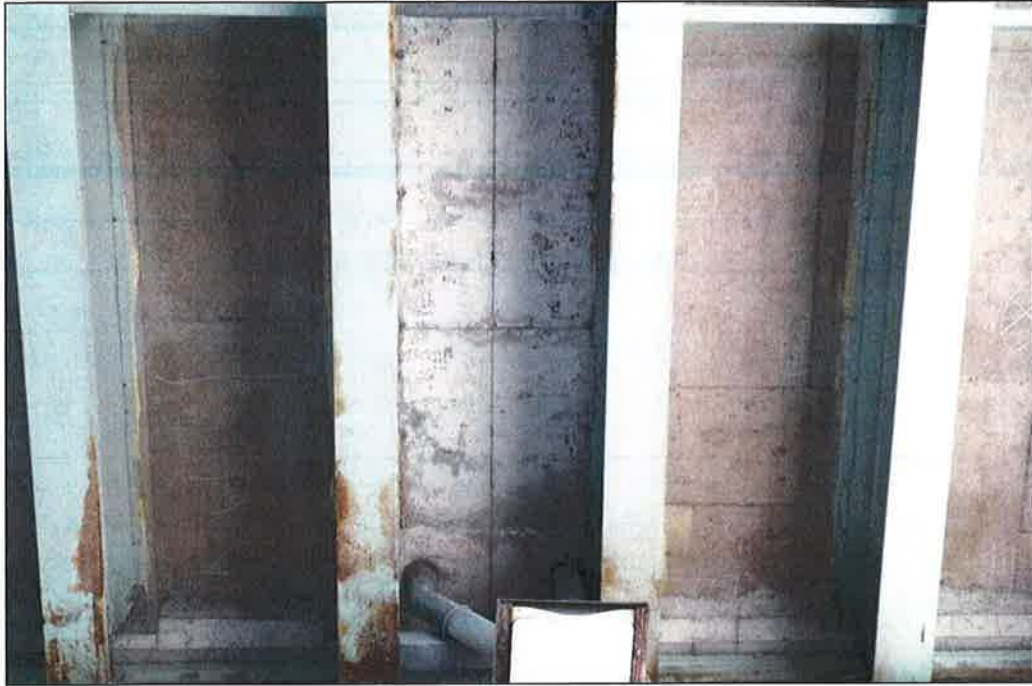
Photo P45 – Typical Condition of Soffit (Bent 301-302) (fair-to-poor condition – stained and unstained cracking, delaminations, spalls, patches, wet areas and light scaling)

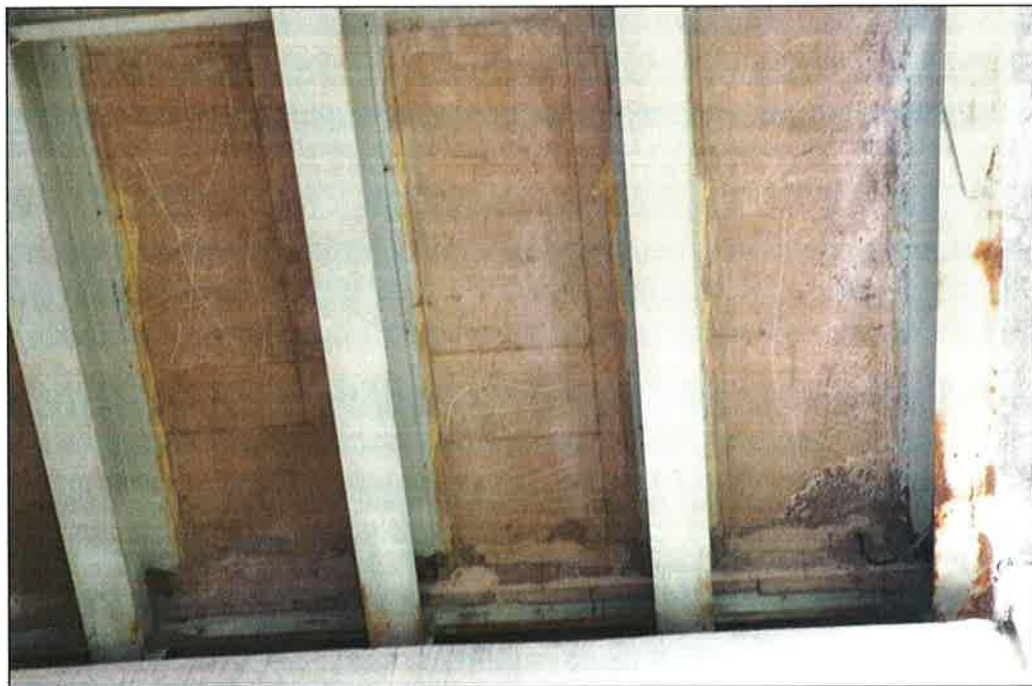
Photo P46 – Typical Condition of Soffit (Bent 301-302) (fair-to-poor condition – stained and unstained cracking, delaminations, spalls, patches, wet areas and light scaling)

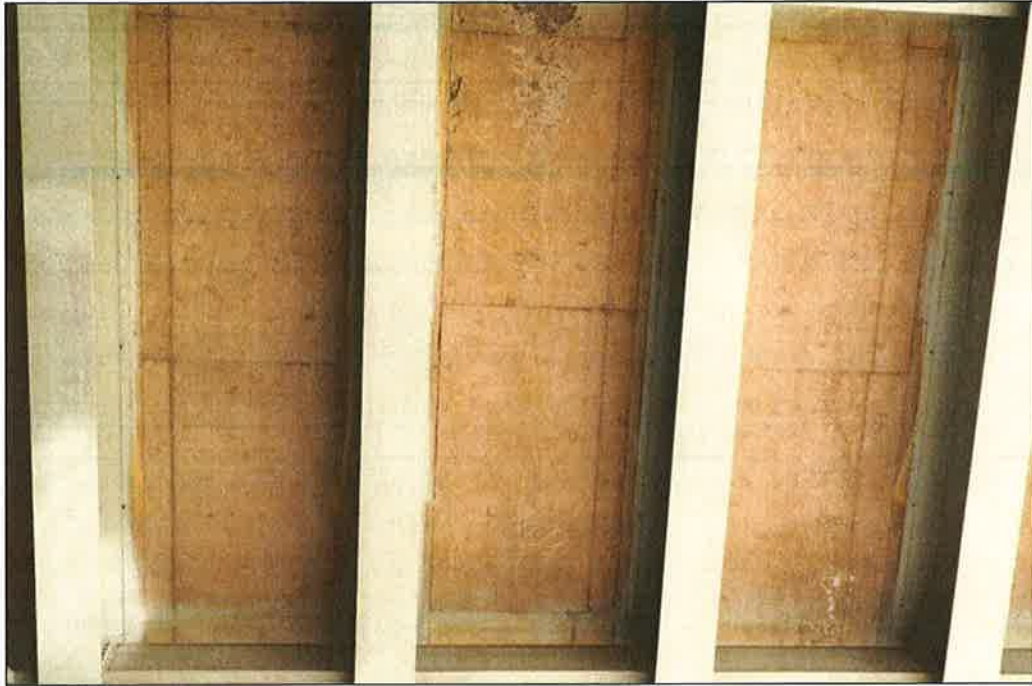
Photo P47 – Typical Condition of Soffit (Bent 301-302) (fair-to-poor condition – stained and unstained cracking, delaminations, spalls, patches, wet areas and light scaling)

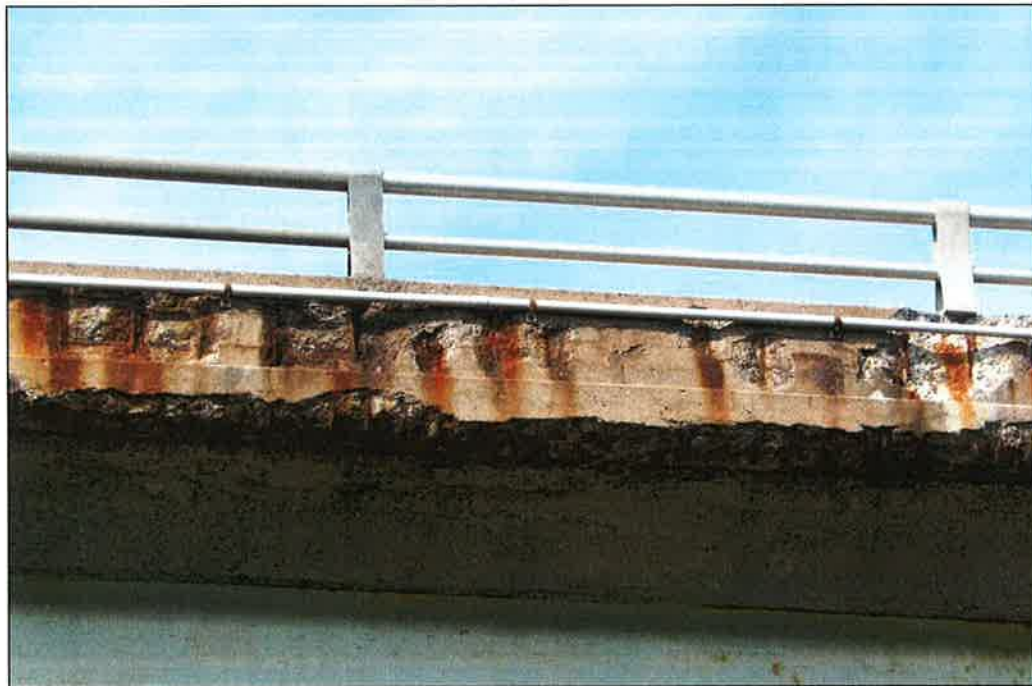
Photo P48 – Typical Condition of Fascia (Bent 301-302) (poor condition –cracking, delaminations and spalls)

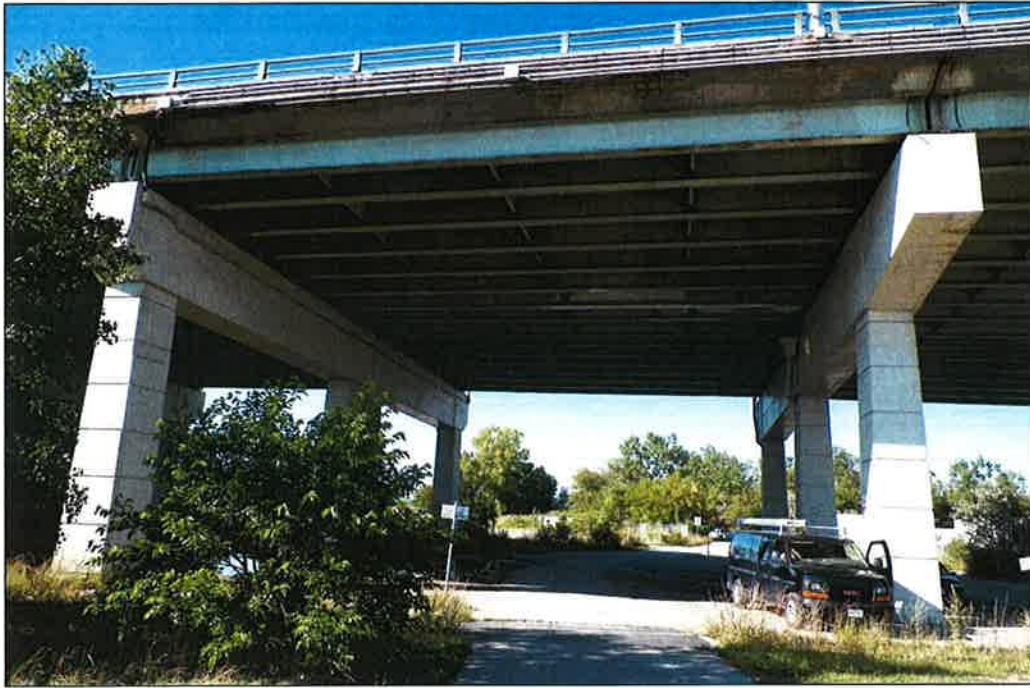
Photo P49 – Elevation (Bent 306-307) (fair condition – stained and unstained cracking, delaminations, spalls, patches, wet areas and light scaling)

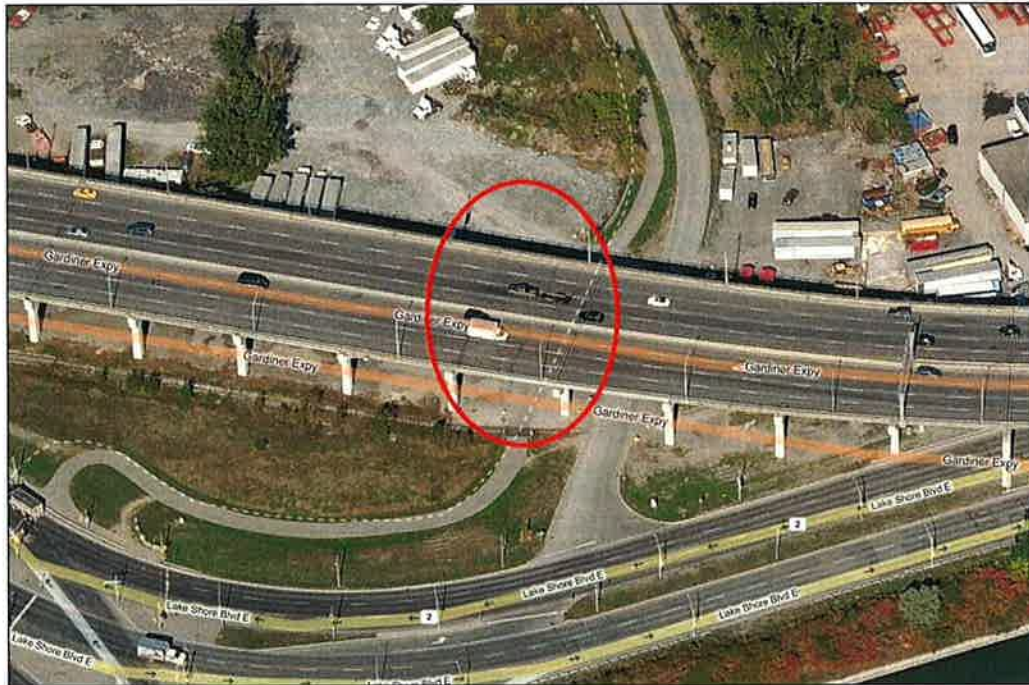
Photo P50 – Aerial Overview of Structure (Bent 306-307) (fair condition – stained and unstained cracking, delaminations, spalls, patches, wet areas and light scaling)

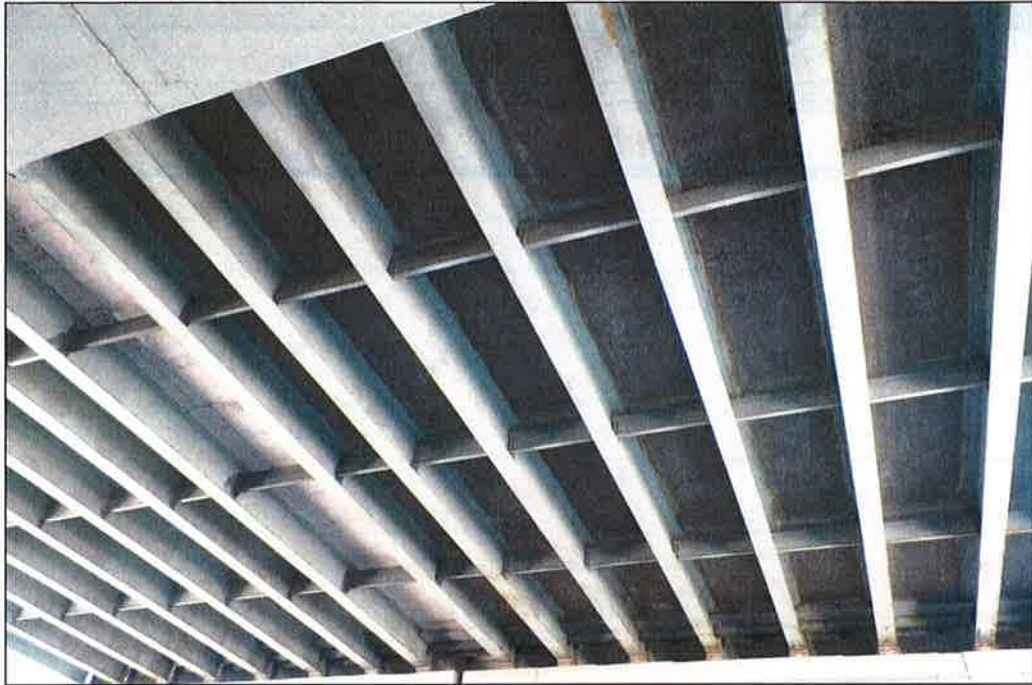
Photo P51 – Typical Condition of Soffit (Bent 306-307) (fair condition – stained and unstained cracking, delaminations, spalls, patches, wet areas and light scaling)

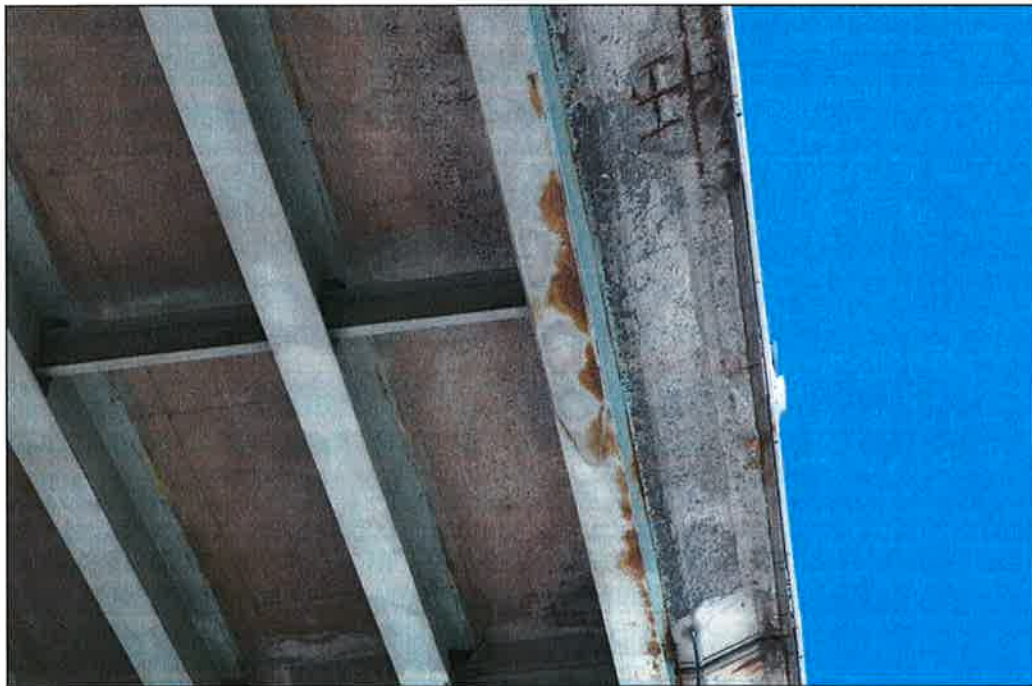
Photo P52 – Typical Condition of Soffit (Bent 306-307) (fair condition – stained and unstained cracking, delaminations, spalls, patches, wet areas and light scaling)

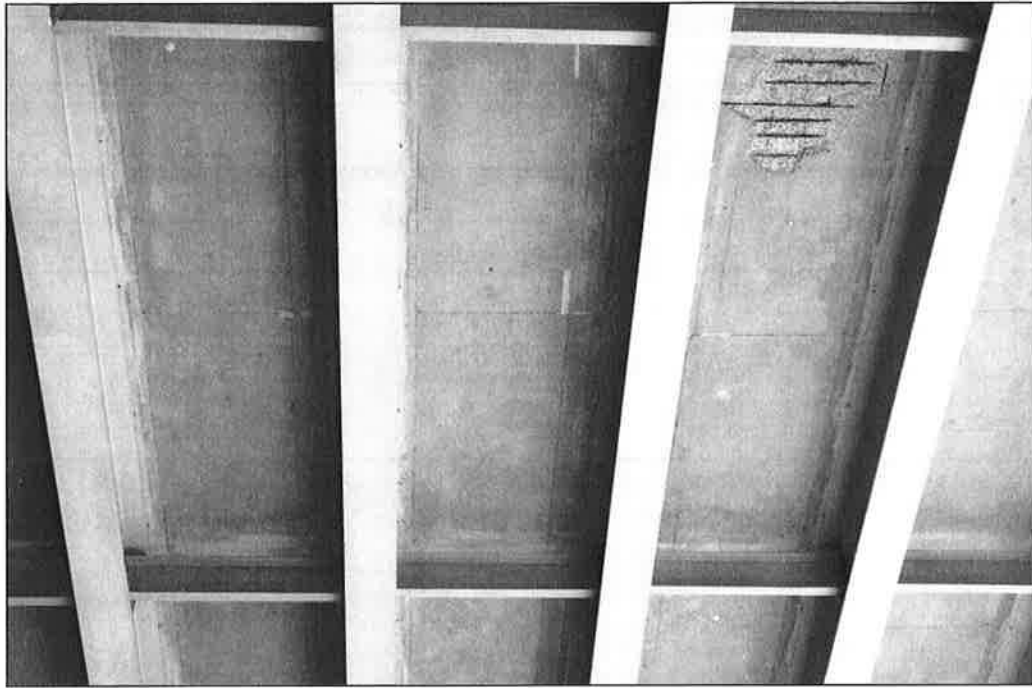
Photo P53 – Typical Condition of Soffit (Bent 306-307) (fair condition – stained and unstained cracking, delaminations, spalls, patches, wet areas and light scaling)

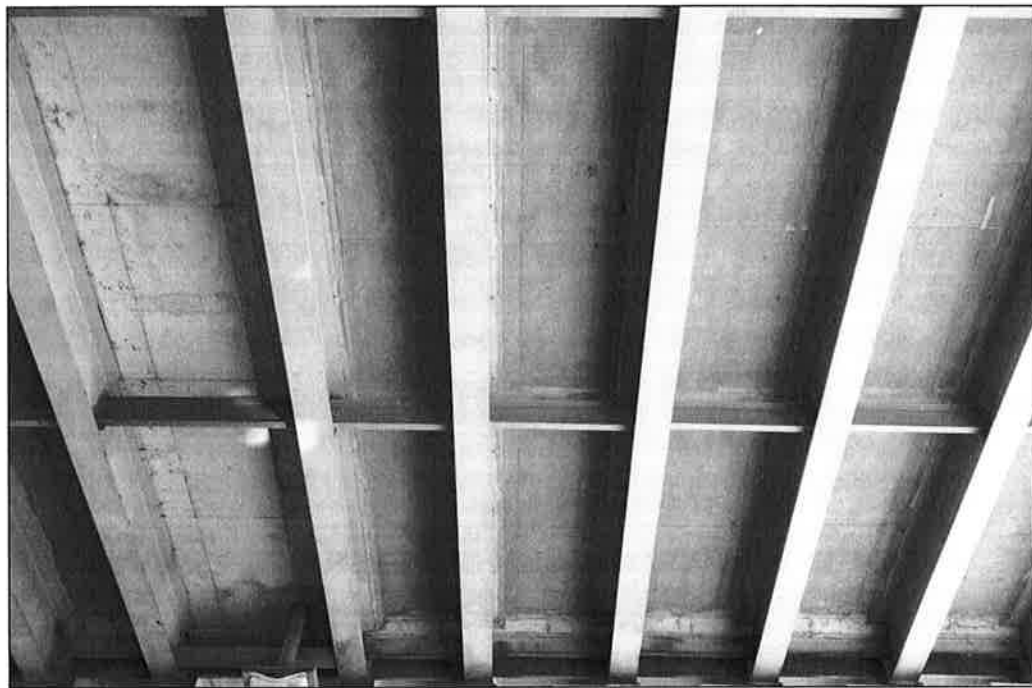
Photo P54 – Typical Condition of Soffit (Bent 306-307) (fair condition – stained and unstained cracking, delaminations, spalls, patches, wet areas and light scaling)

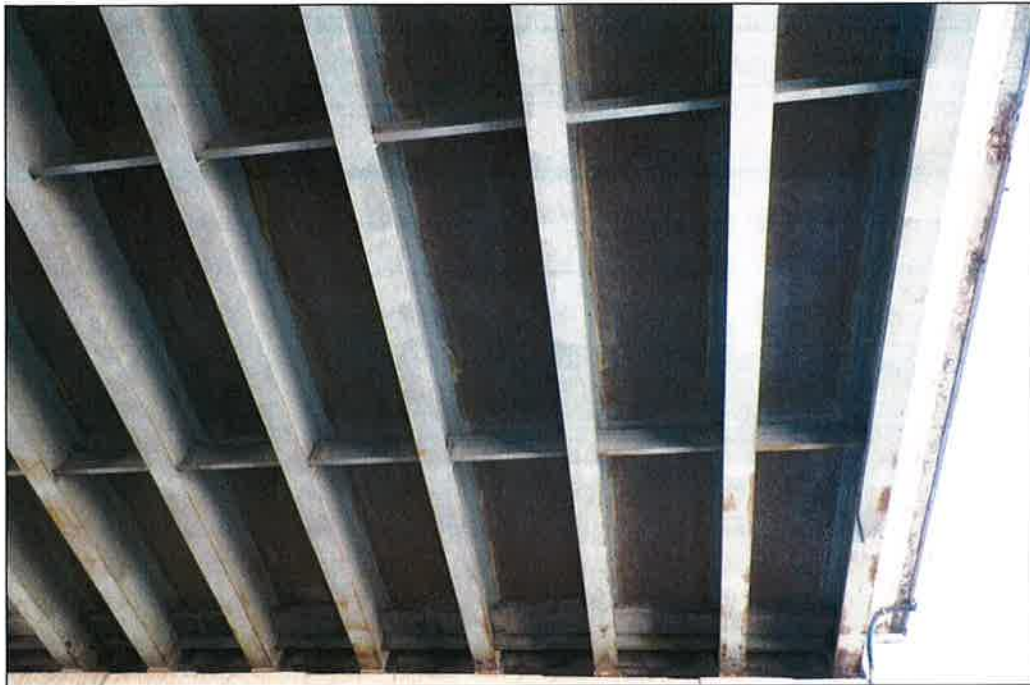
Photo P55 – Typical Condition of Soffit (Bent 306-307) (fair condition – stained and unstained cracking, delaminations, spalls, patches, wet areas and light scaling)

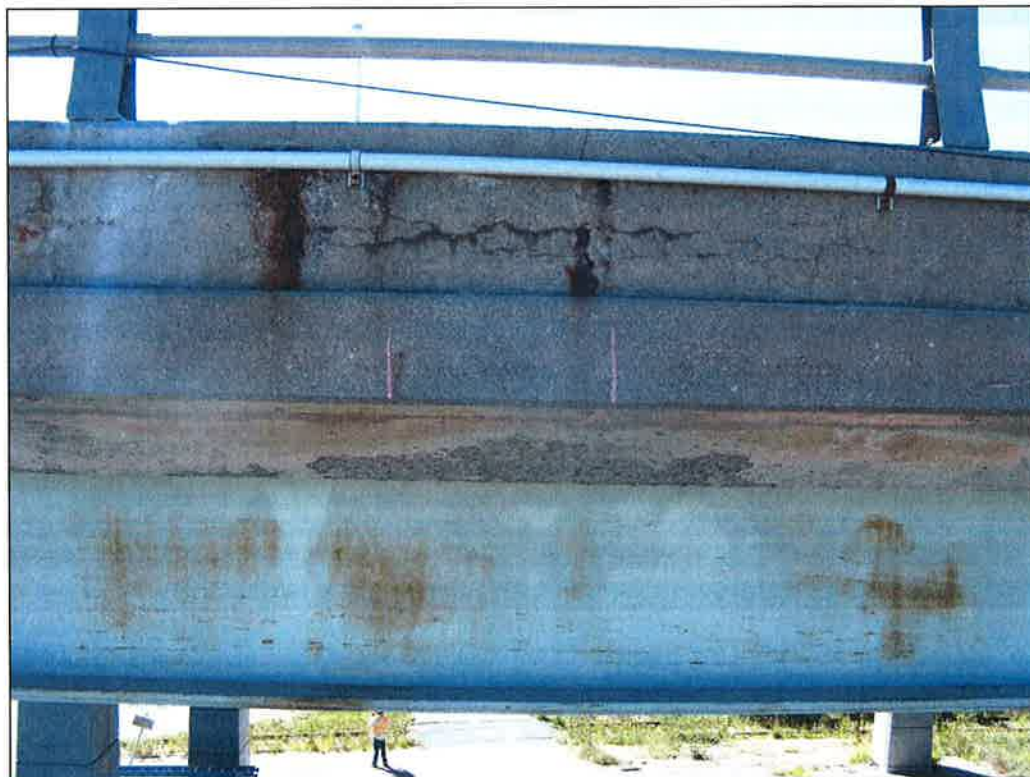
Photo P56 – Typical Condition of Fascia (Bent 306-307) (poor condition – cracking, spalls and localized patches)

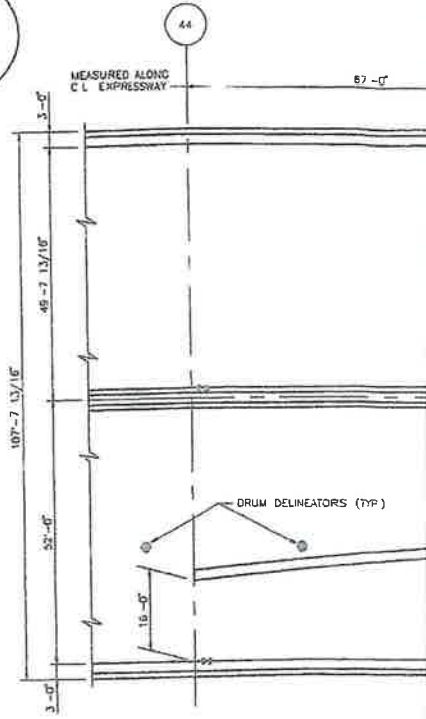
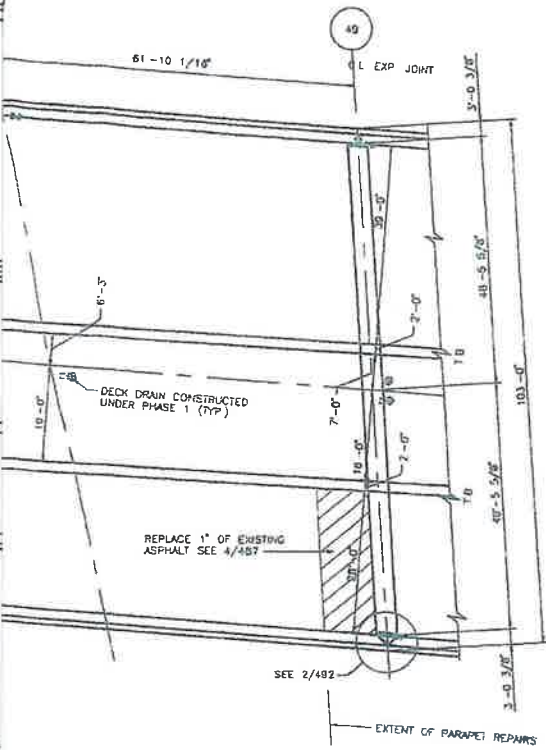
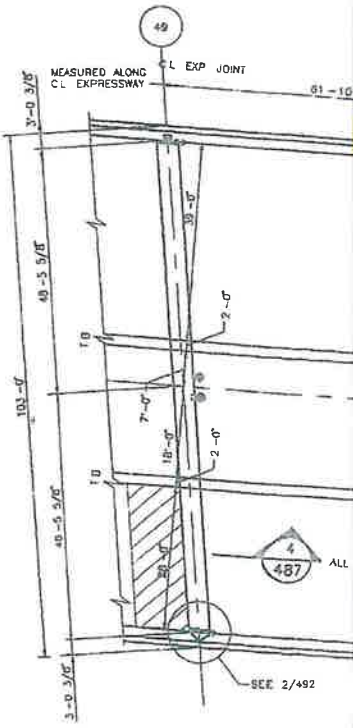
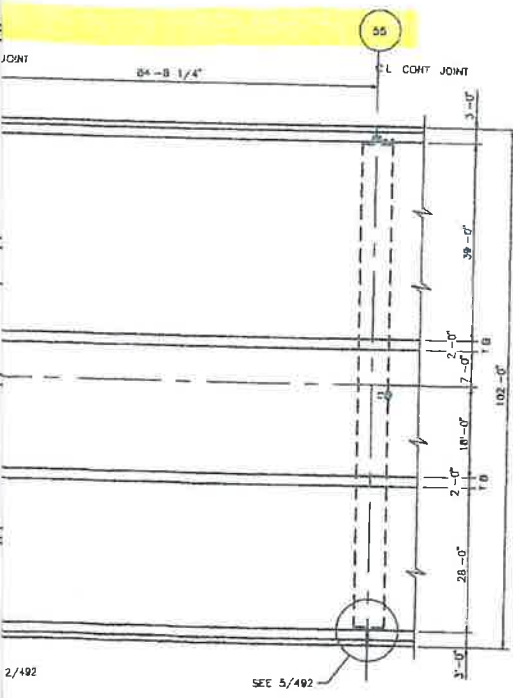
PLOT DATE 29 DEC 1991
