IBI Group
30 International Boulevard
Toronto ON M9W 5P3 Canada
tel 416 679 1930
fax 416 675 4620

September 10, 2012

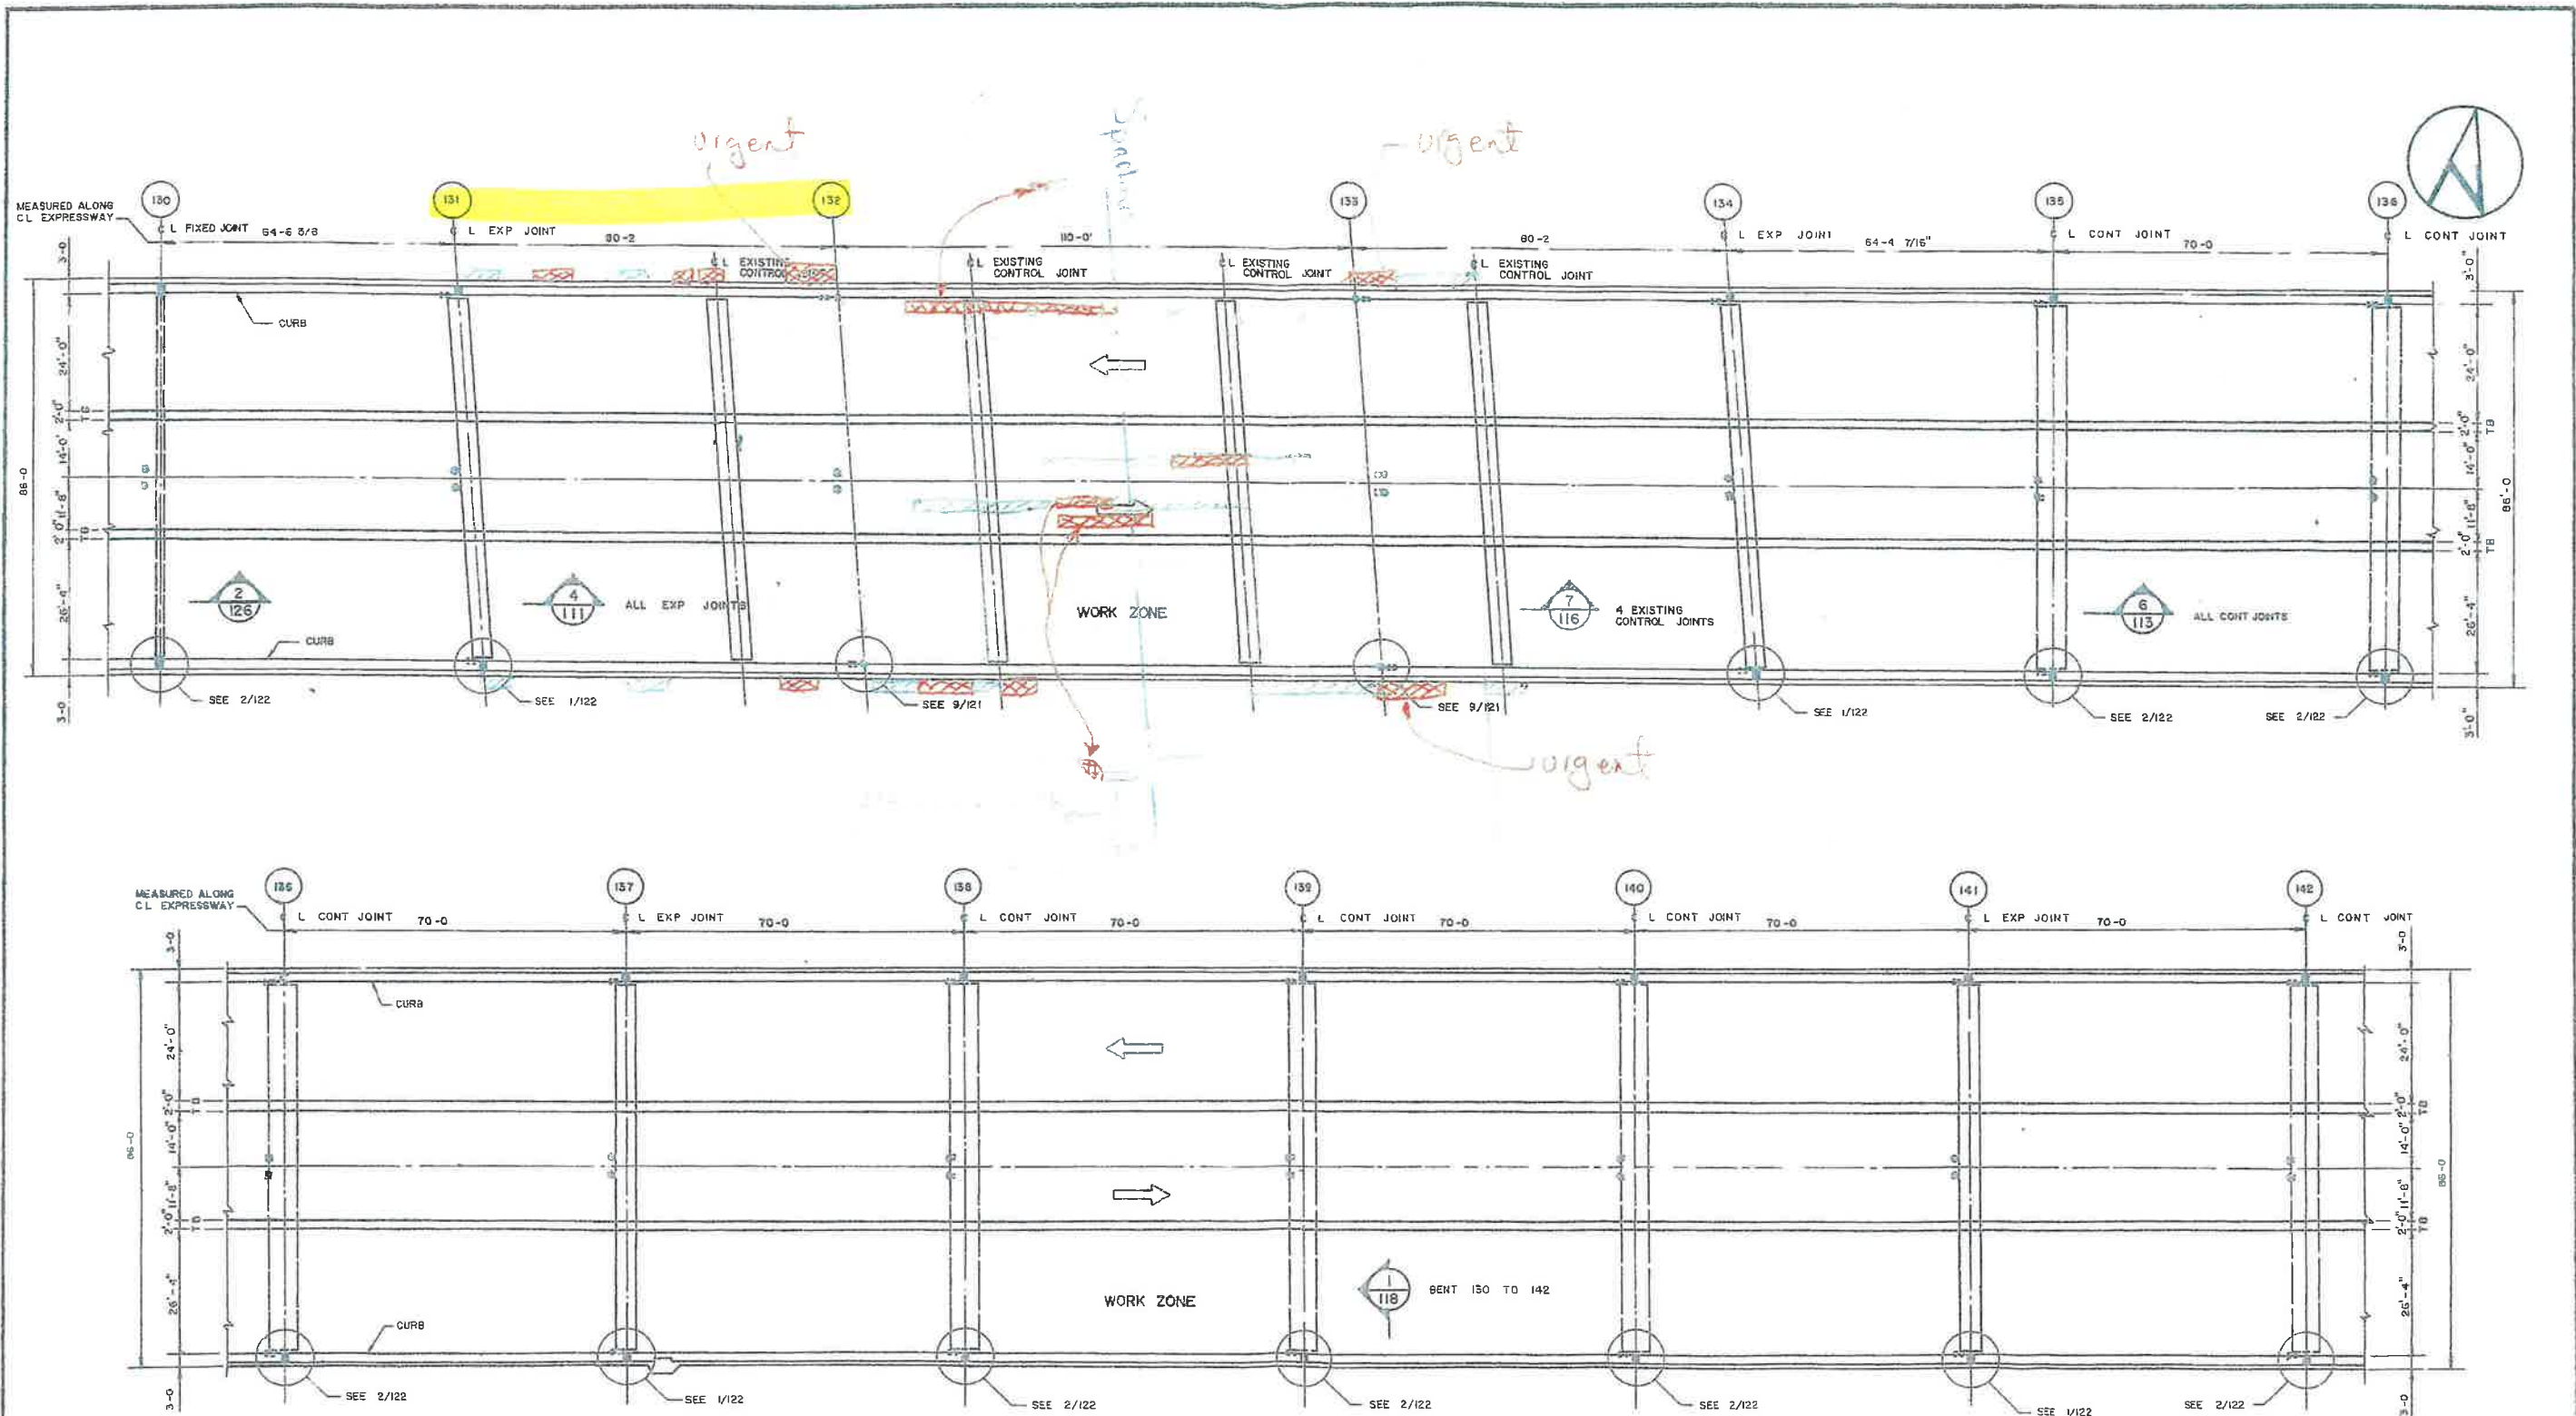
REP DWG.	TITLE	No.	DATE	AS BUILT ISSUED FOR CONSTRUCTION	BY
		2	FEB 91	AS BUILT	A.P.
		1	3190	ISSUED FOR CONSTRUCTION	L.T.
				REVISIONS

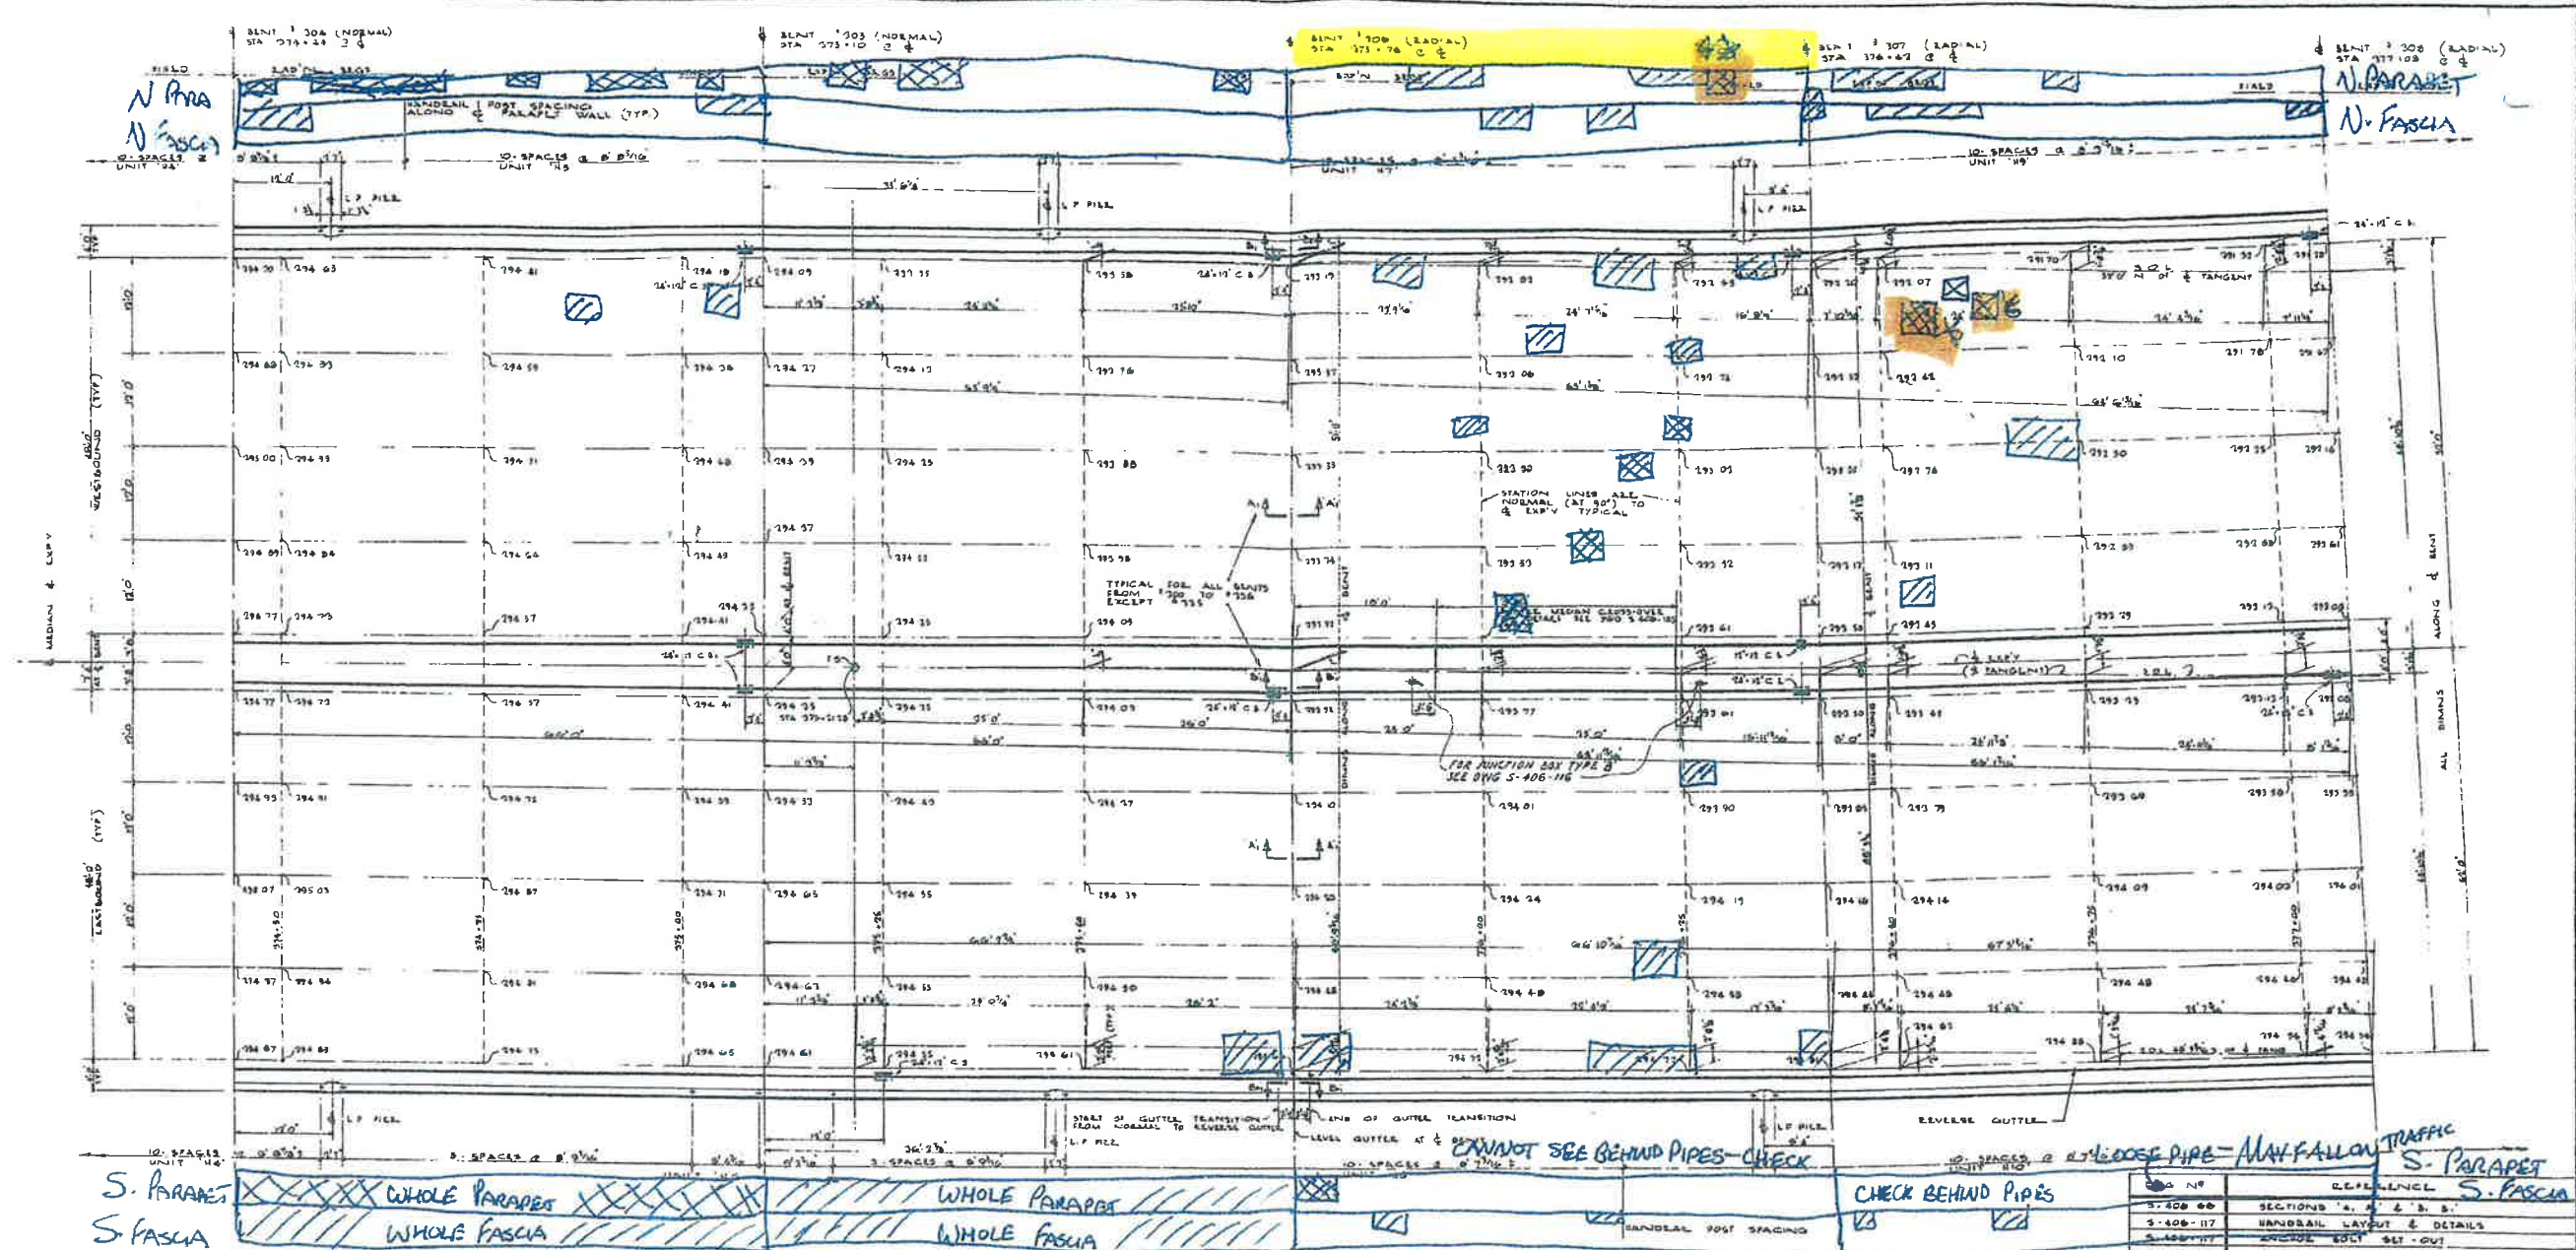
S. PARAPET
S. FASCIA

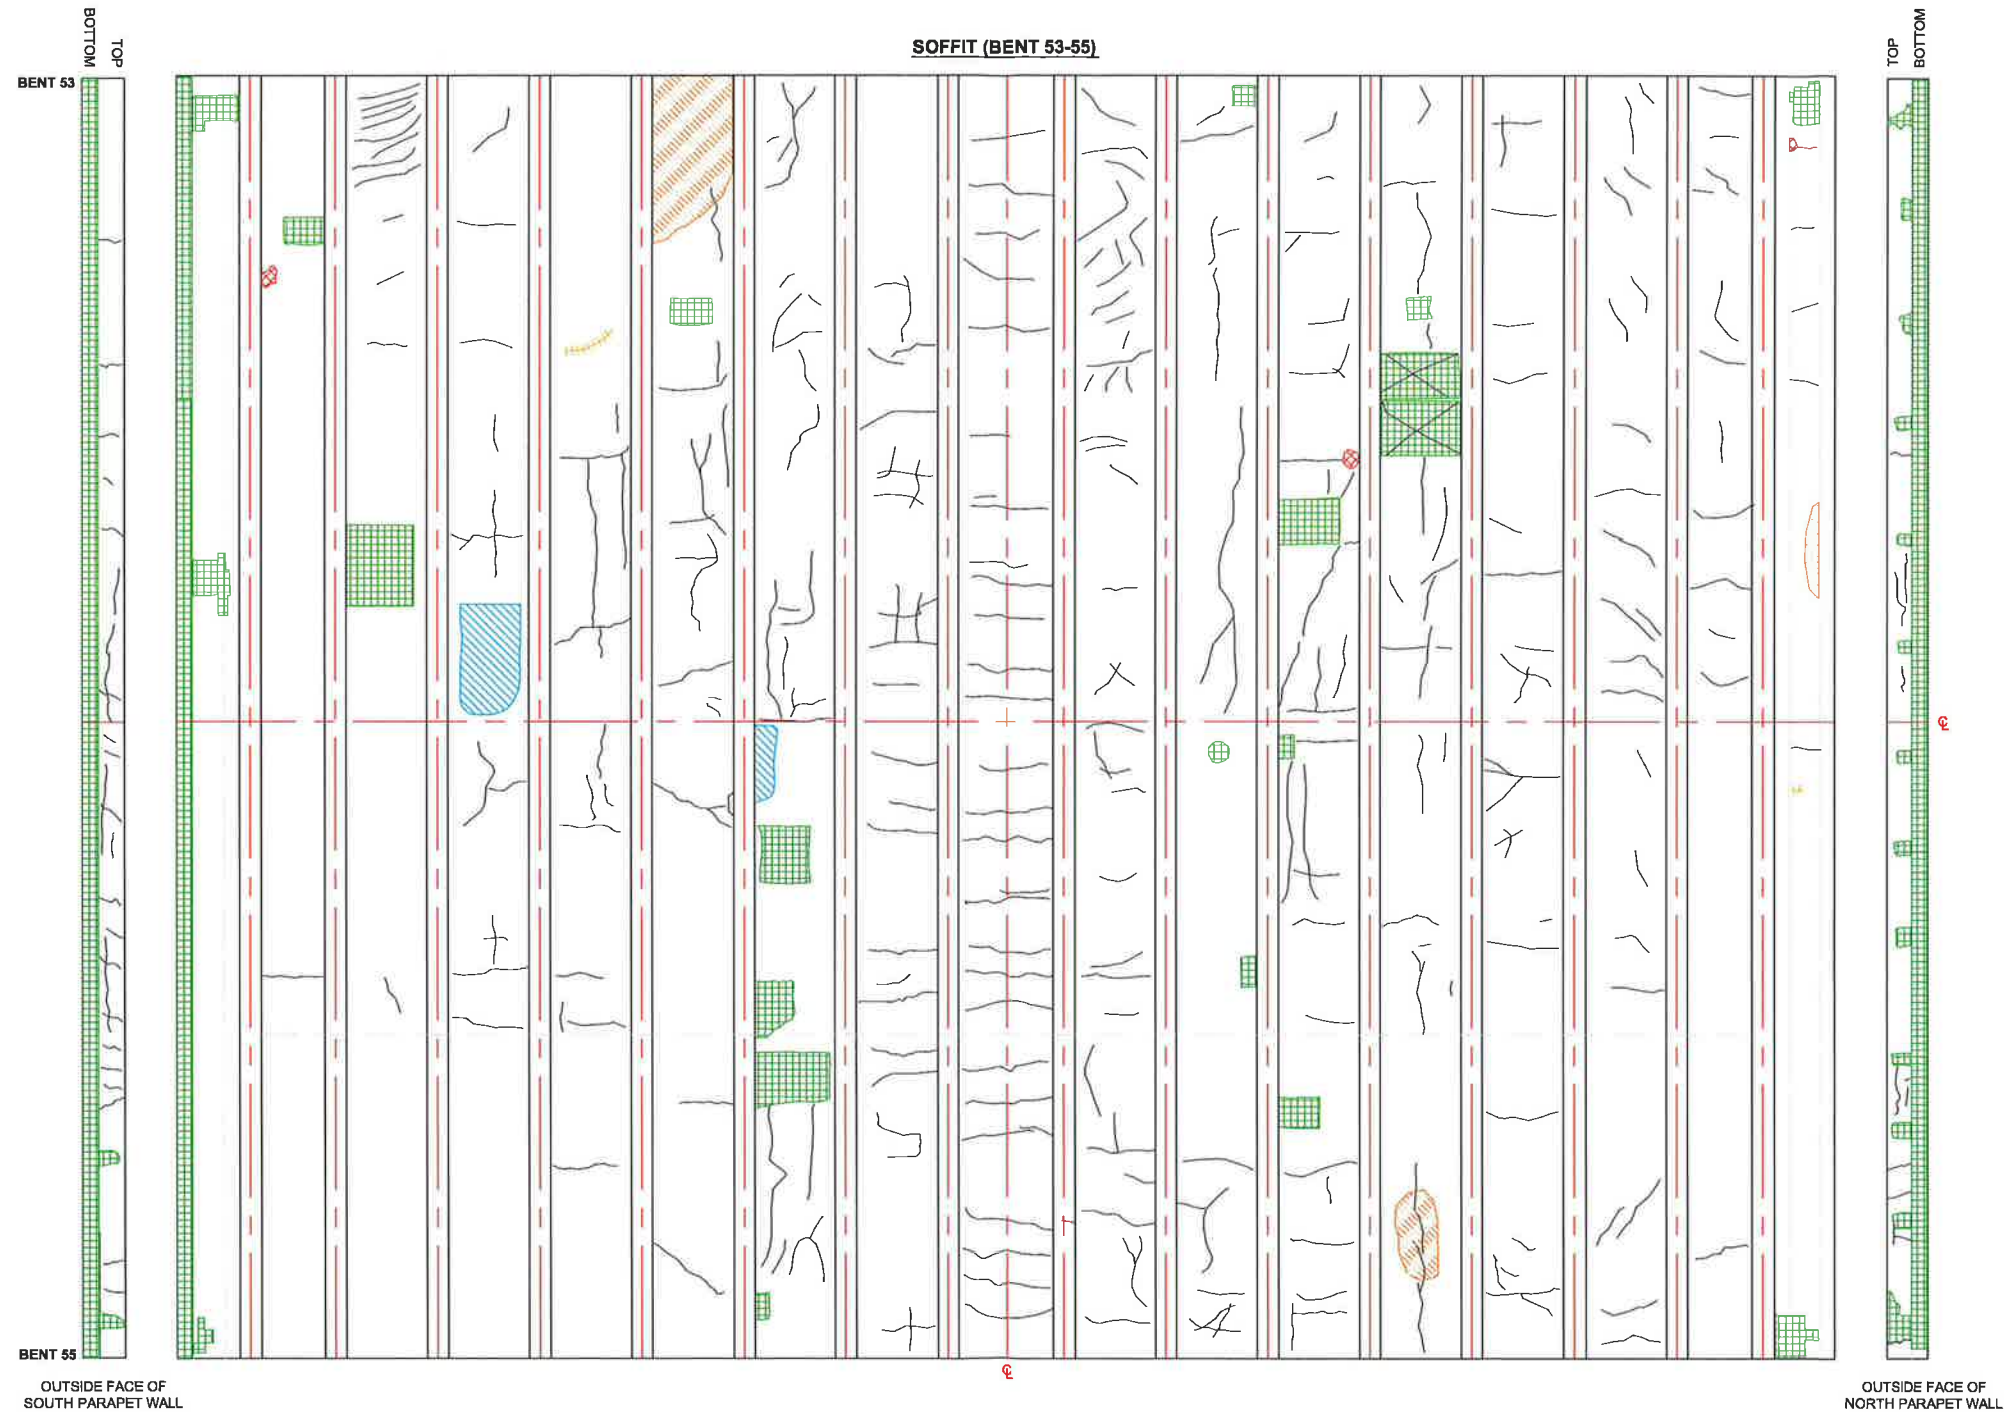
NOTE: 2012 City of Toronto Visual Survey indicated no signs of surface deterioration.

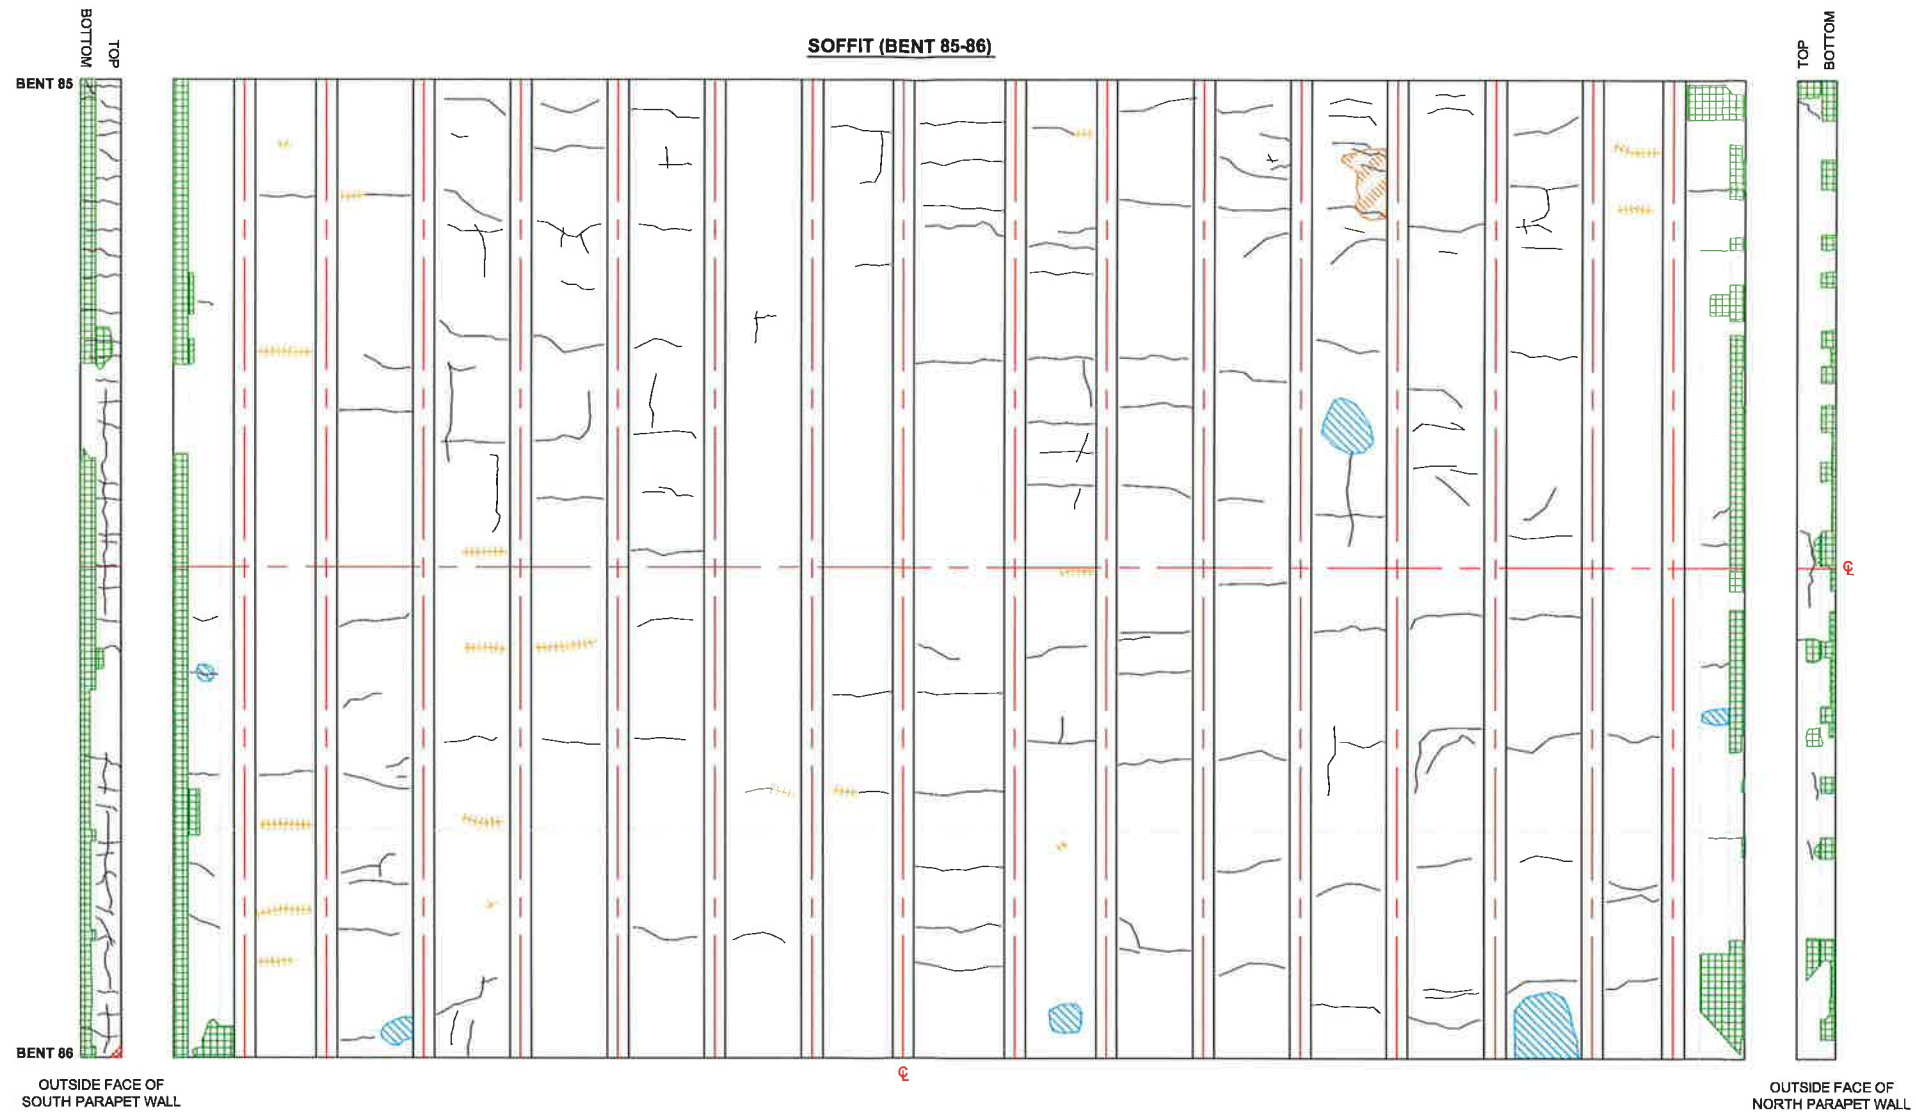
NOTE: 2012 City of Toronto Visual Survey indicated one small spall on outside face of parapet wall.

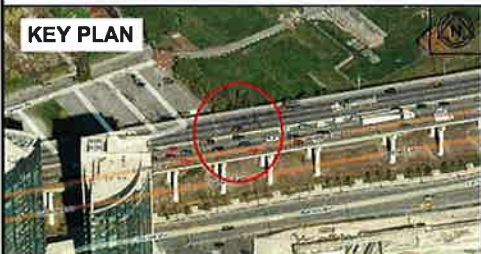
- legend:
- Ⓞ Drain
 - Ⓞ Honey-combed Area
 - Ⓞ Patched Spall
 - Ⓞ Delamination
 - Ⓞ Light Scaling
 - Ⓞ Medium Stained Crack
 - Ⓞ Spall
 - Ⓞ Wet Area
 - Ⓞ Medium Concrete Crack

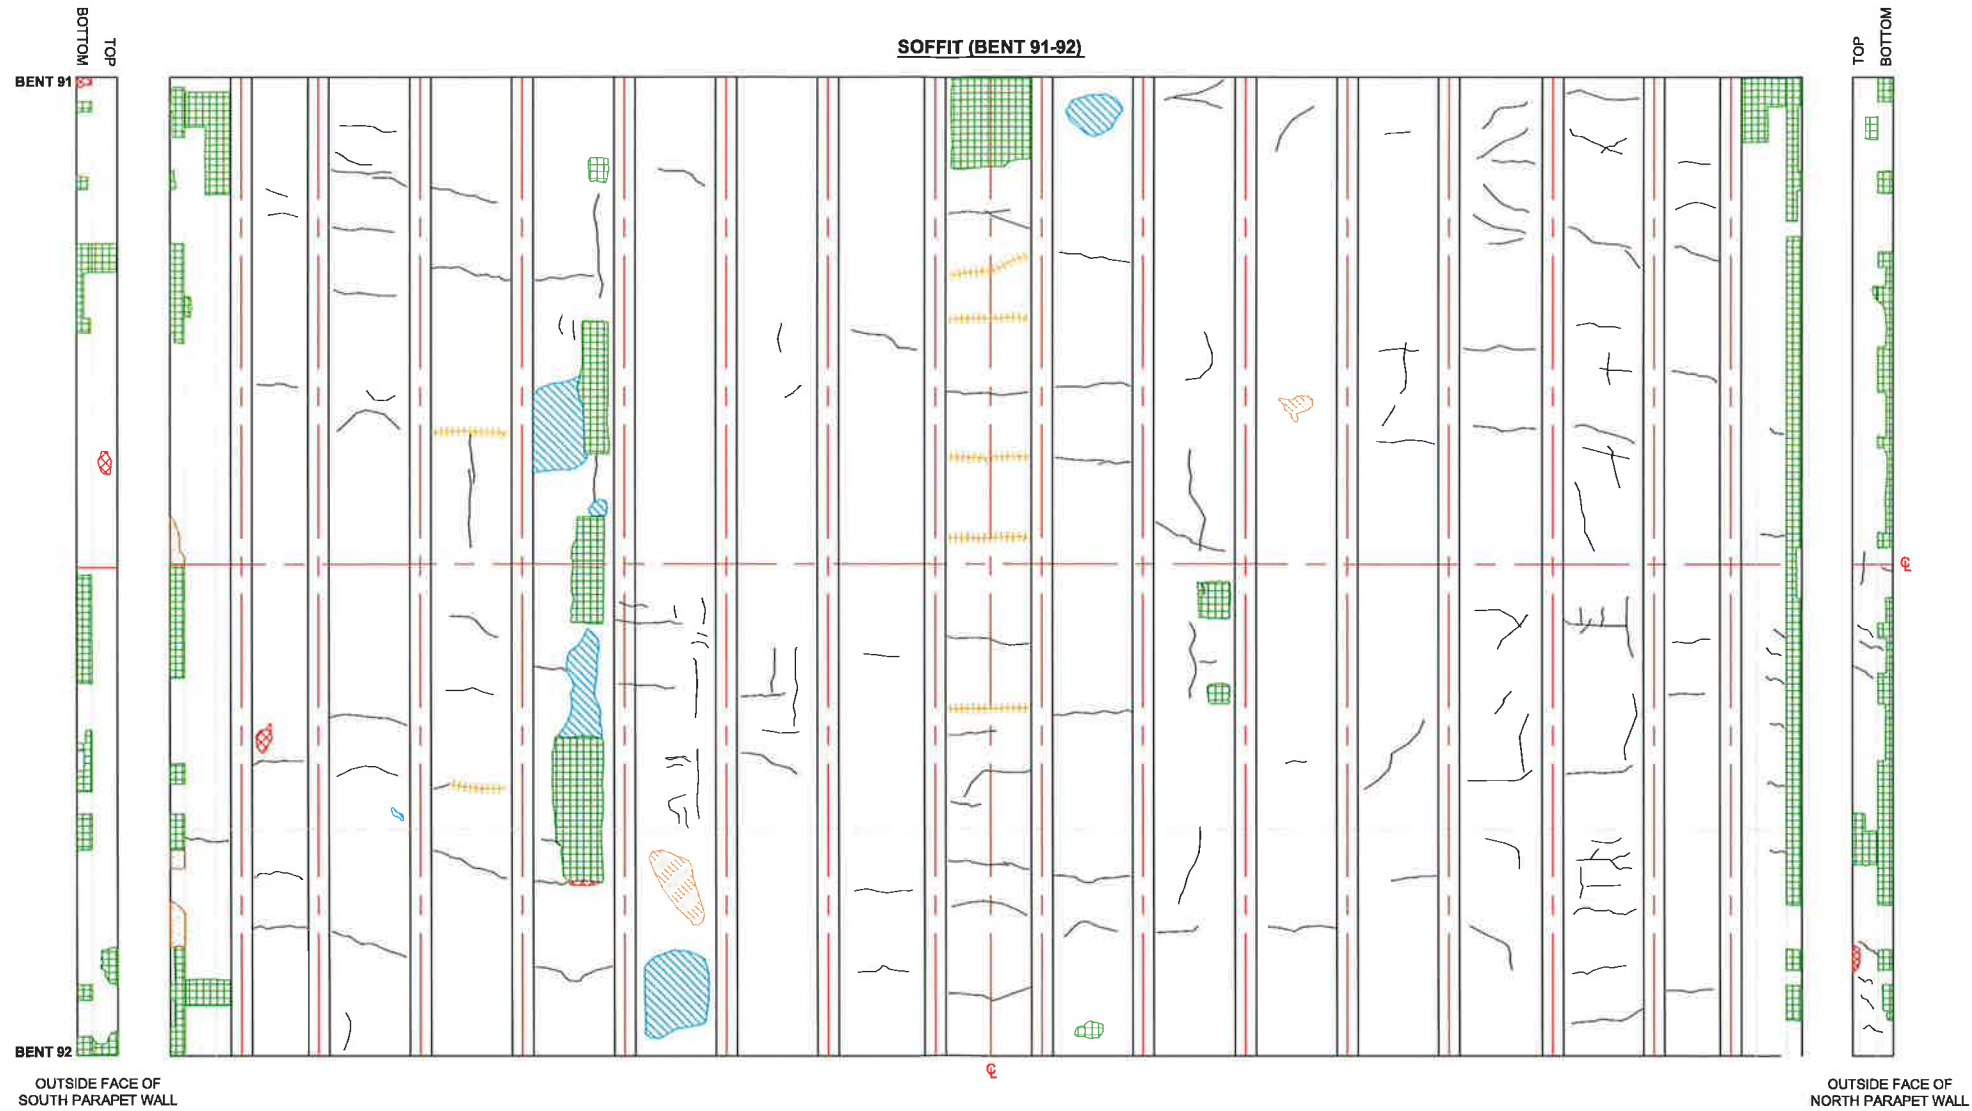
NOTE: 2012 City of Toronto Visual Survey indicated no signs of surface deterioration.

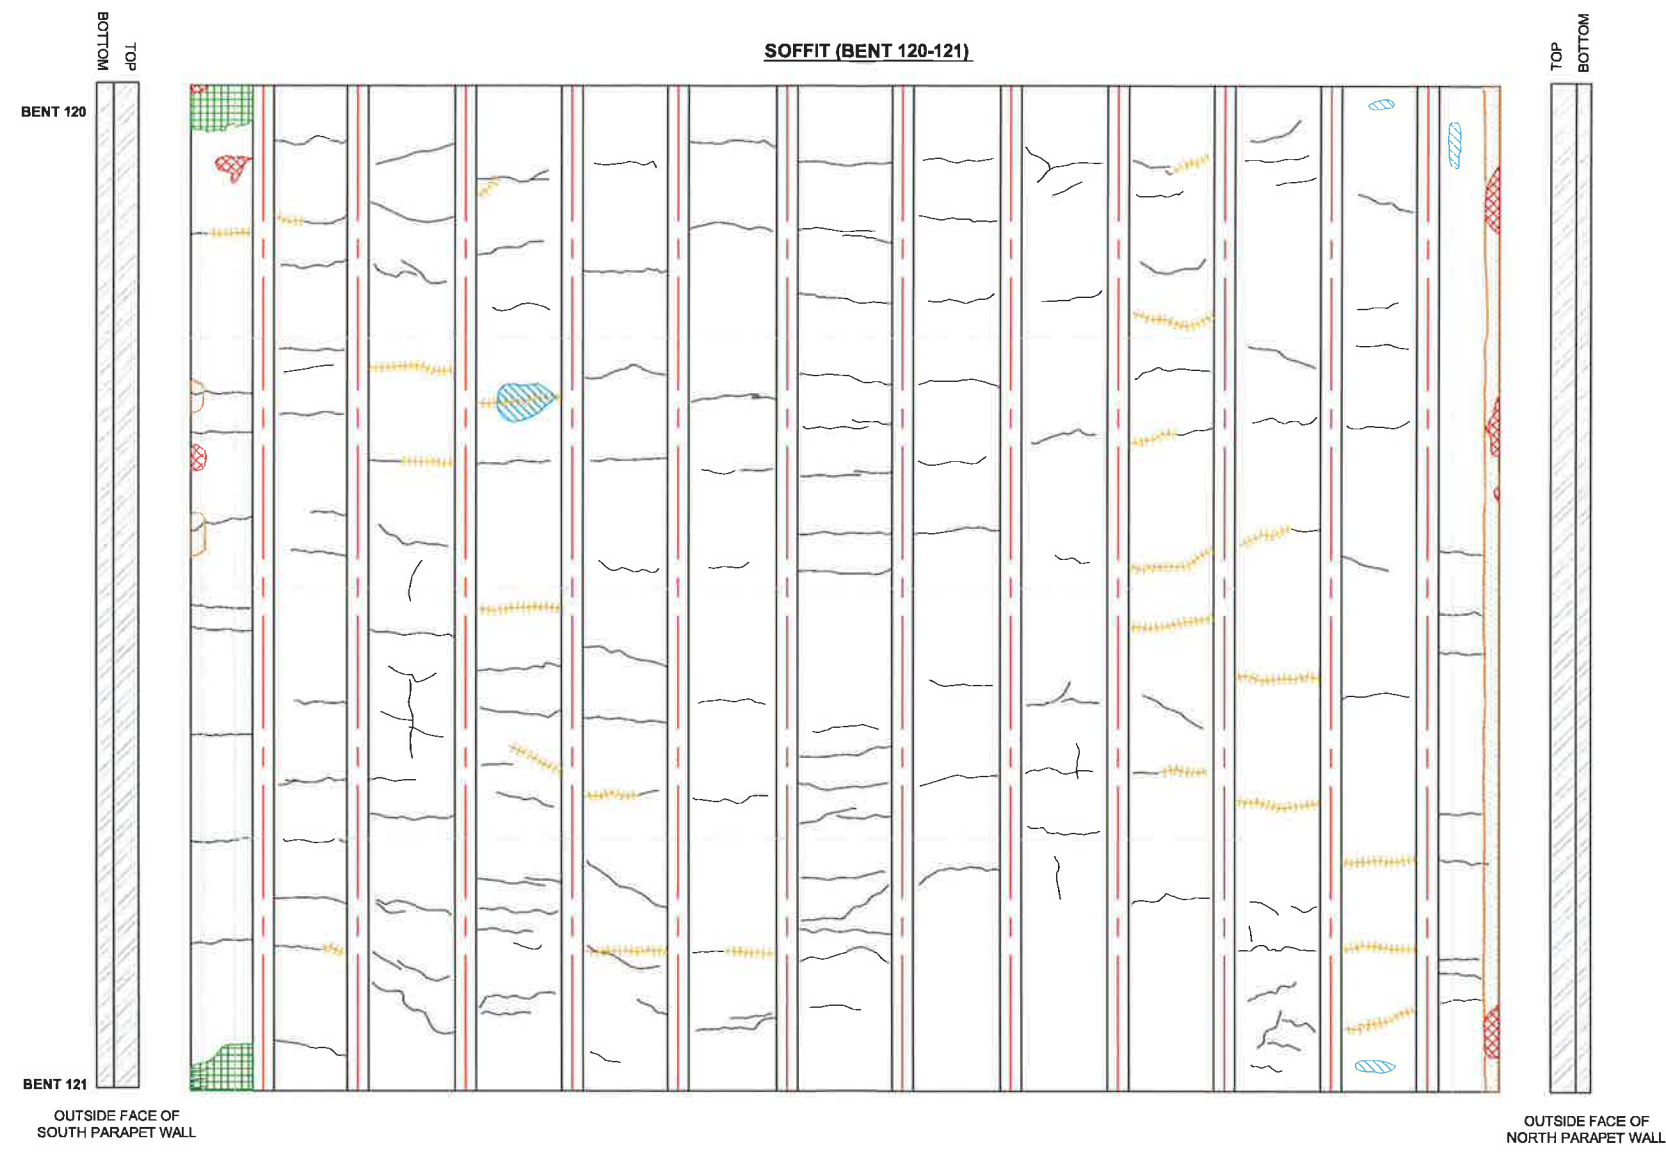
NOTE: 2012 City of Toronto Visual Survey indicated one localized spall area.

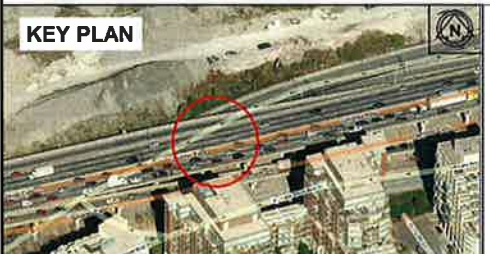
- legend:
- Drain
 - Honey-combed Area
 - Patched Spall
 - Delamination
 - Light Scaling
 - Medium Stained Crack
 - Medium Concrete Crack
 - Spall
 - Wet Area
 - Inaccessible Area

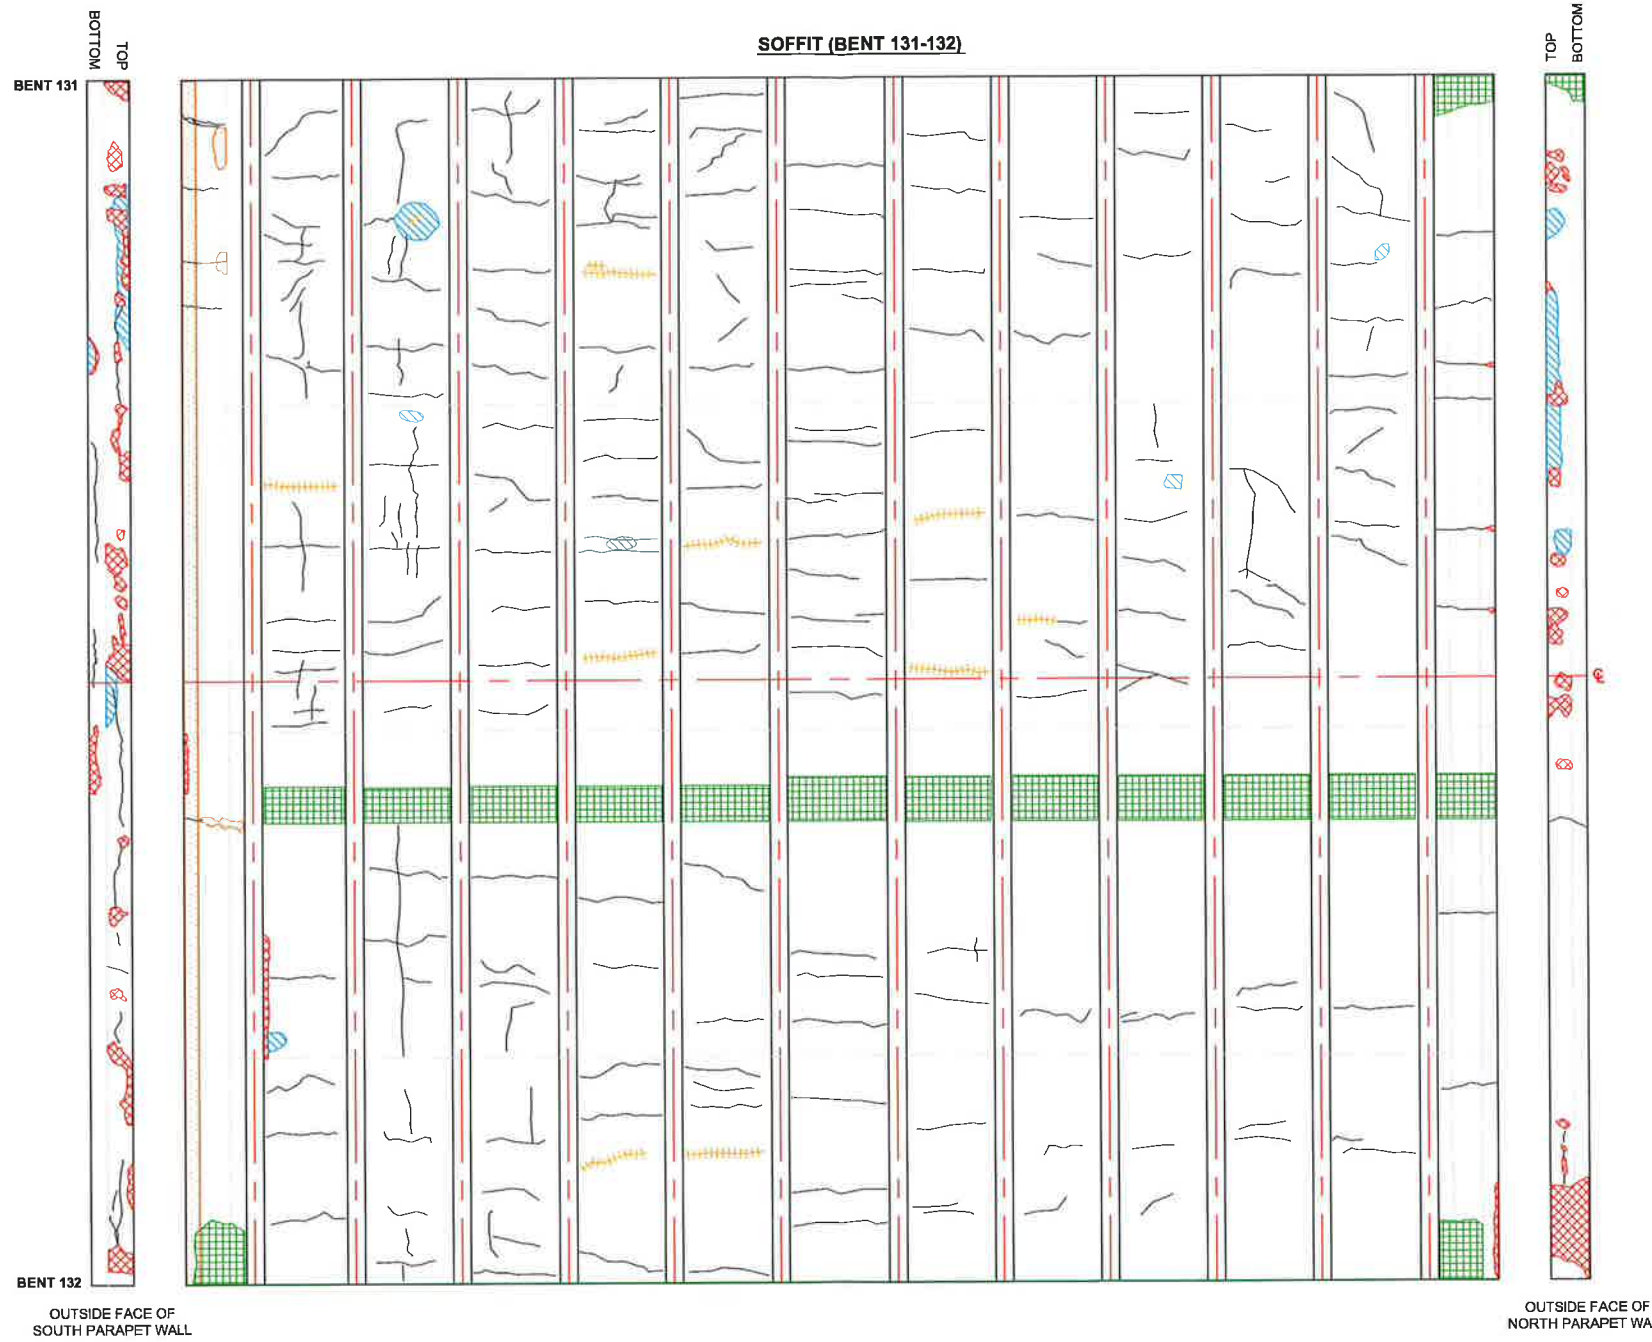
NOTE: 2012 City of Toronto Visual Survey indicated no signs of surface distress on soffit; and three localized areas of delaminations and five localized areas of spalls on outside face of parapet walls.

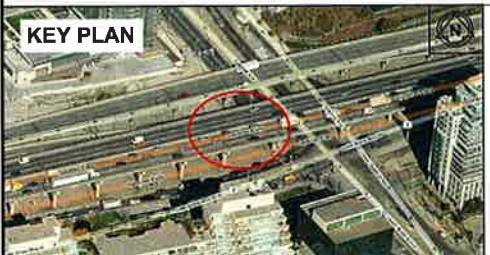
- legend:
- Drain
 - Delamination
 - Spall
 - Honey-combed Area
 - Light Scaling
 - Wet Area
 - Patched Spall
 - Medium Stained Crack
 - Medium Concrete Crack

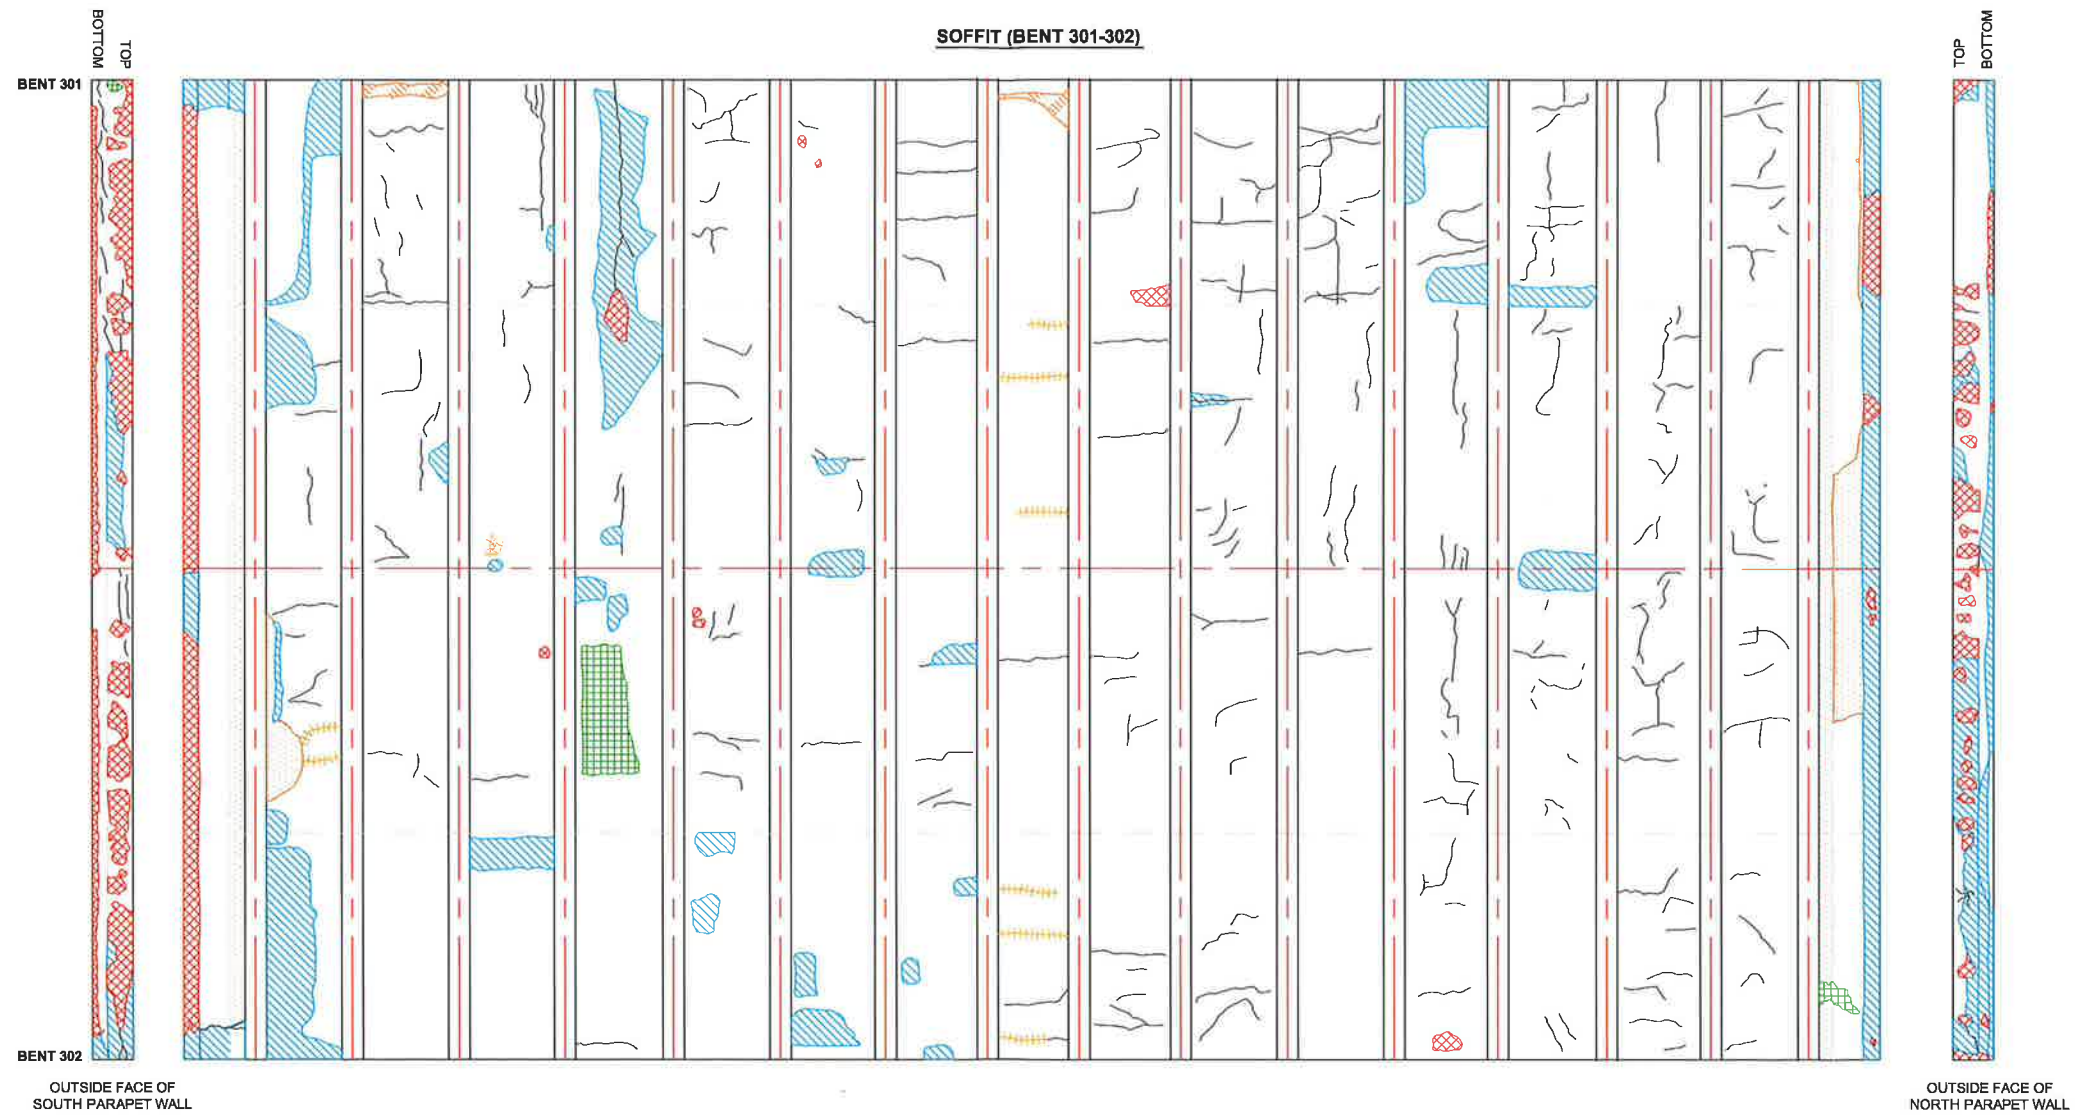
NOTE: 2012 City of Toronto Visual Survey indicated two localized areas of delaminations on the soffit; and three localized area of spalls on the north parapet wall and the entire south parapet wall indicated spalls.
