IBI Group
30 International Boulevard
Toronto ON M9W 5P3 Canada
tel 416 679 1930
fax 416 675 4620

September 10, 2012

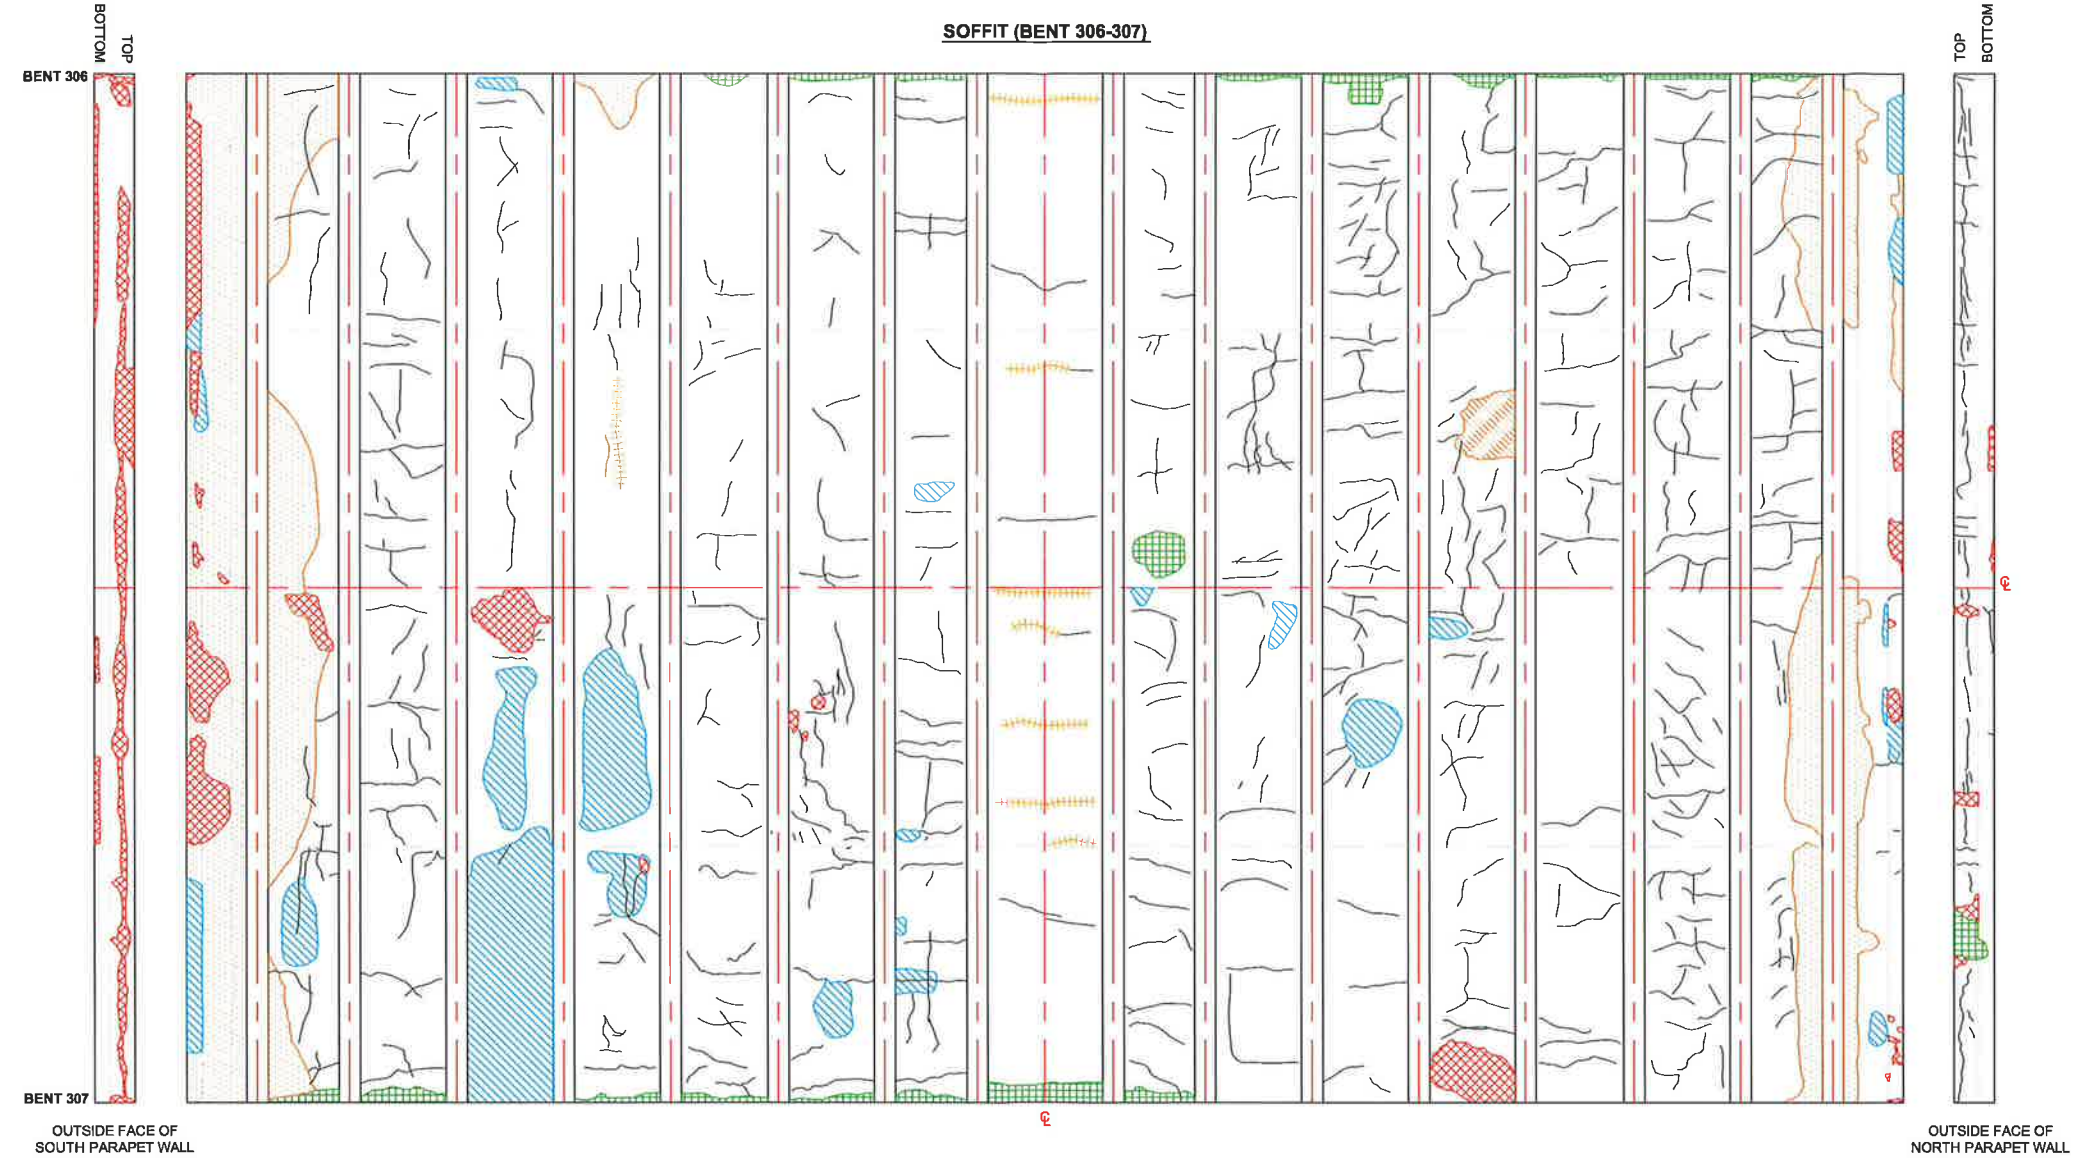
NOTE: 2012 City of Toronto Visual Survey indicated four small spalls and eleven small delaminations on soffit; two small areas of spalls and six small areas of delaminations on outside face of parapet walls.

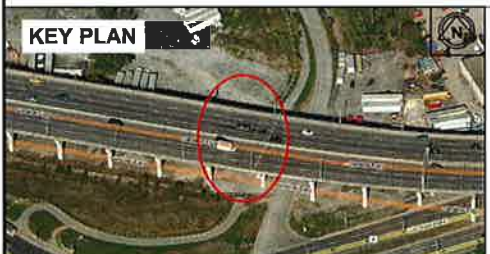
- legend:
- Drain
 - Honey-combed Area
 - Patched Spall
 - Delamination
 - Light Scaling
 - Medium Stained Crack
 - Wet Area
 - Medium Concrete Crack
